## **Park Place Condominium Lynnwood, WA**

Report #: 38175-0  
Beginning: January 1, 2023  
Expires: December 31, 2023

**RESERVE STUDY  
"Full"**

July 20, 2022

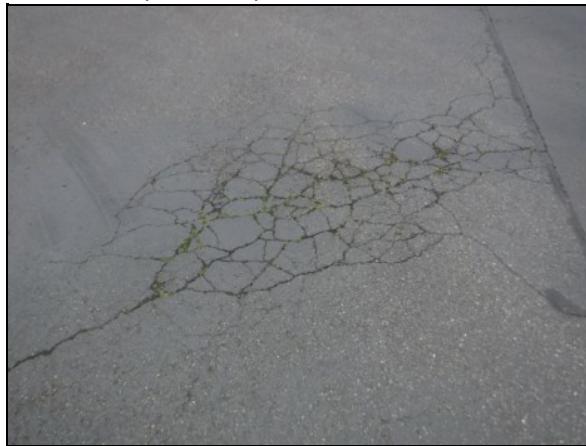
Pavement Surface Condition Field Rating Manual for Asphalt Pavement:

<https://www.wsdot.wa.gov/publications/manuals/fulltext/m0000/AsphaltPavements.pdf>Washington Asphalt Pavement Association: <http://www.asphaltwa.com/>Useful Life:  
30 yearsRemaining Life:  
6 years

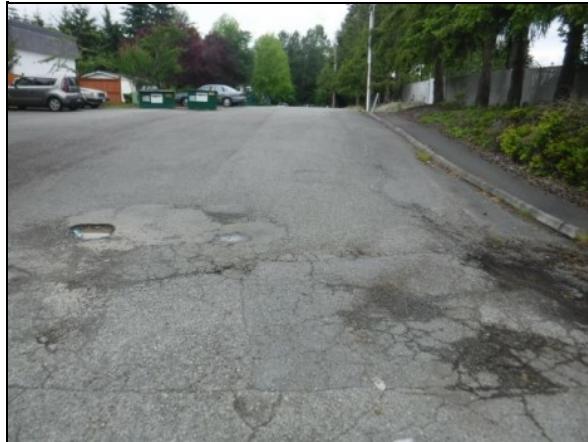
Useful Life:  
30 years

Remaining Life:  
6 years

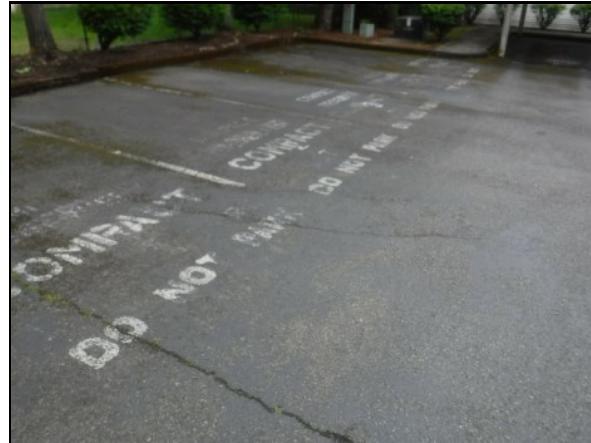
Asphalt Pavement Maintenance Best Practices Handbook: <http://www.cee.mtu.edu/~balkire/CE5403/AsphaltPaveMaint.pdf>Asphalt Seal Coat Treatments General Overview: <https://www.wsdot.wa.gov/research/reports/fullreports/136.1.pdf>Other: <http://www.pavementinteractive.org/article/bituminous-surface-treatments/>Useful Life:  
5 yearsRemaining Life:  
1 years

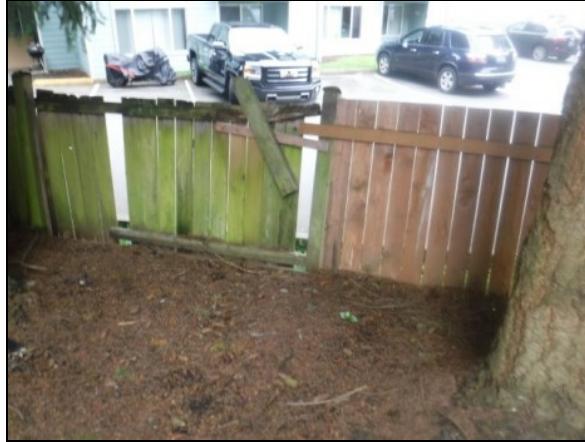
As routine maintenance, inspect regularly for any damage, and repair as needed. Avoid unnecessary contact with the ground, sprinkler patterns, and surrounding vegetation. Regular cycles of stain/paint will help to maintain appearance. Painting or staining the fence has a higher overall life cycle cost, but may extend life in addition to an aesthetic benefit.

Useful Life:  
20 yearsRemaining Life:  
0 years

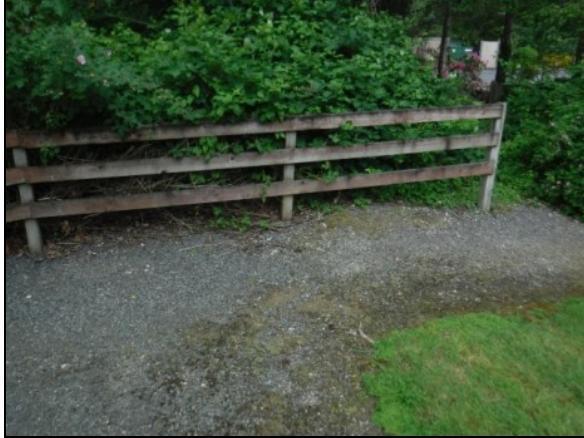
As routine maintenance, inspect regularly for any damage and repair locally, as needed, using operating funds. Avoid unnecessary contact with the ground, sprinkler patterns, and surrounding vegetation. Typically, split rail fences are left to weather naturally, but can be stained for appearance and protection.

Useful Life:  
25 yearsRemaining Life:  
9 years

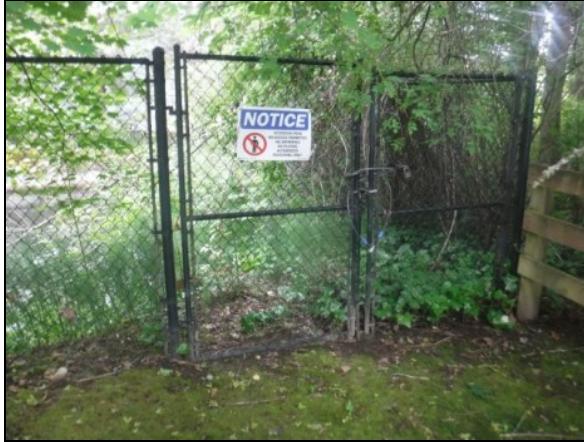
Chain link fencing is generally a low maintenance item. Inspect periodically, and repair as needed. If corrosion is observed, apply a rust inhibitor to prevent corrosion from decreasing the useful life.

Useful Life:  
40 yearsRemaining Life:  
17 years

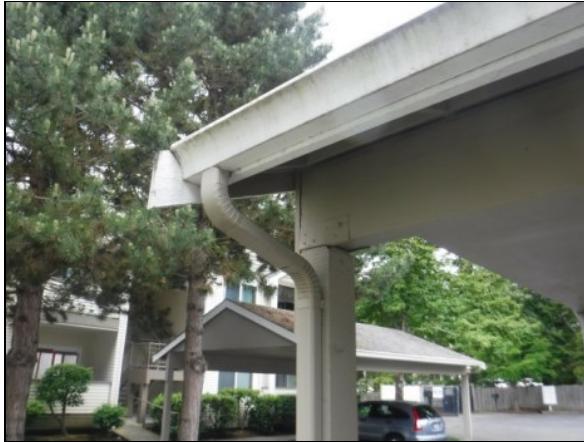
Useful Life:  
25 years

Remaining Life:  
2 years

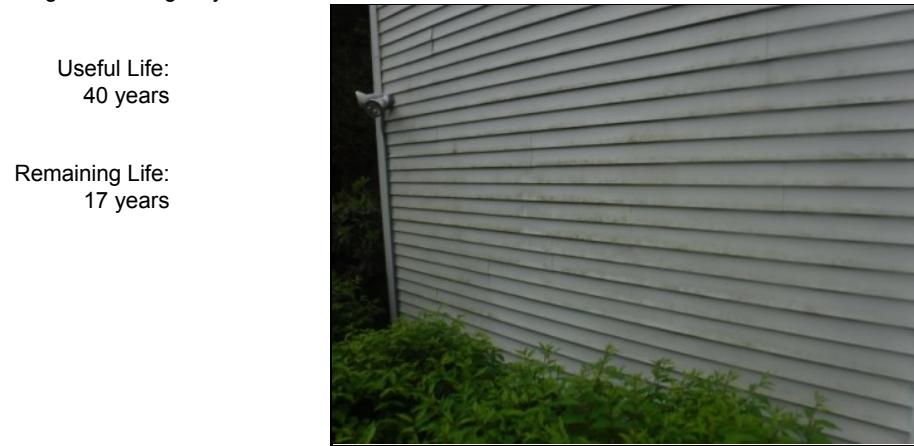
Project costs can vary depending upon materials chosen and the condition of the underlying structural framing when exposed. We recommend the Board conduct research well in advance in order to define the scope, timing, and costs; including a plan for some margin of contingency.

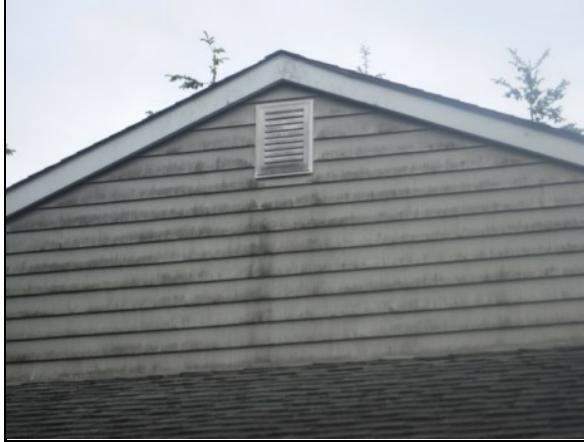
It is best practice to clean vinyl siding every few years to remove contaminants that can reduce its service life, and to maintain appearance. This is also a good opportunity to have the exterior sealant inspected. We have projected the higher end of the cost range for cleaning to include sealant inspection at the same time as power washing. When washing, we advise not to use too high of pressure, and ensure spray angles do not allow water beneath the vinyl. Hand washing is also available, but is often more expensive.

Useful Life:  
4 yearsRemaining Life:  
0 years

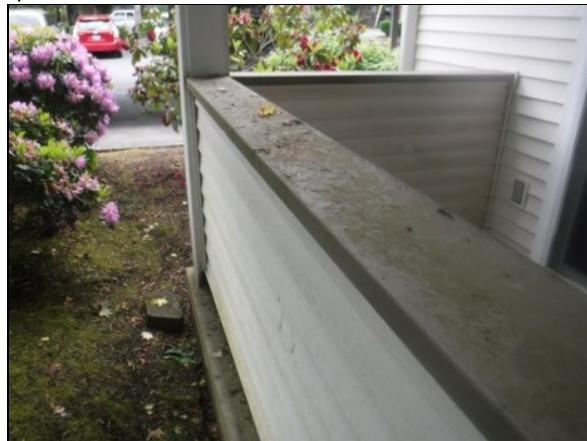
Useful Life:  
8 years

Remaining Life:  
0 years

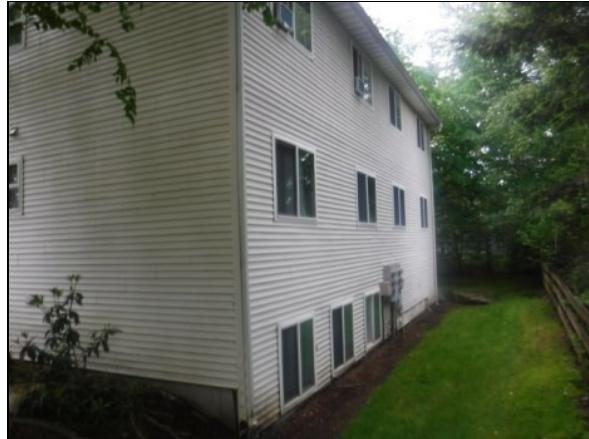
Fenestration & Glazing Industry Alliance (formerly AAMA): <https://fgiaonline.org/>Useful Life:  
40 years

Remaining Life:  
17 years
