December 2, 2024

Bid #R-1202A24S

Property Address
"Park Place Homes"
19726 -19732 50th Ave W
Lynnwood, WA 98036

Summary of Findings

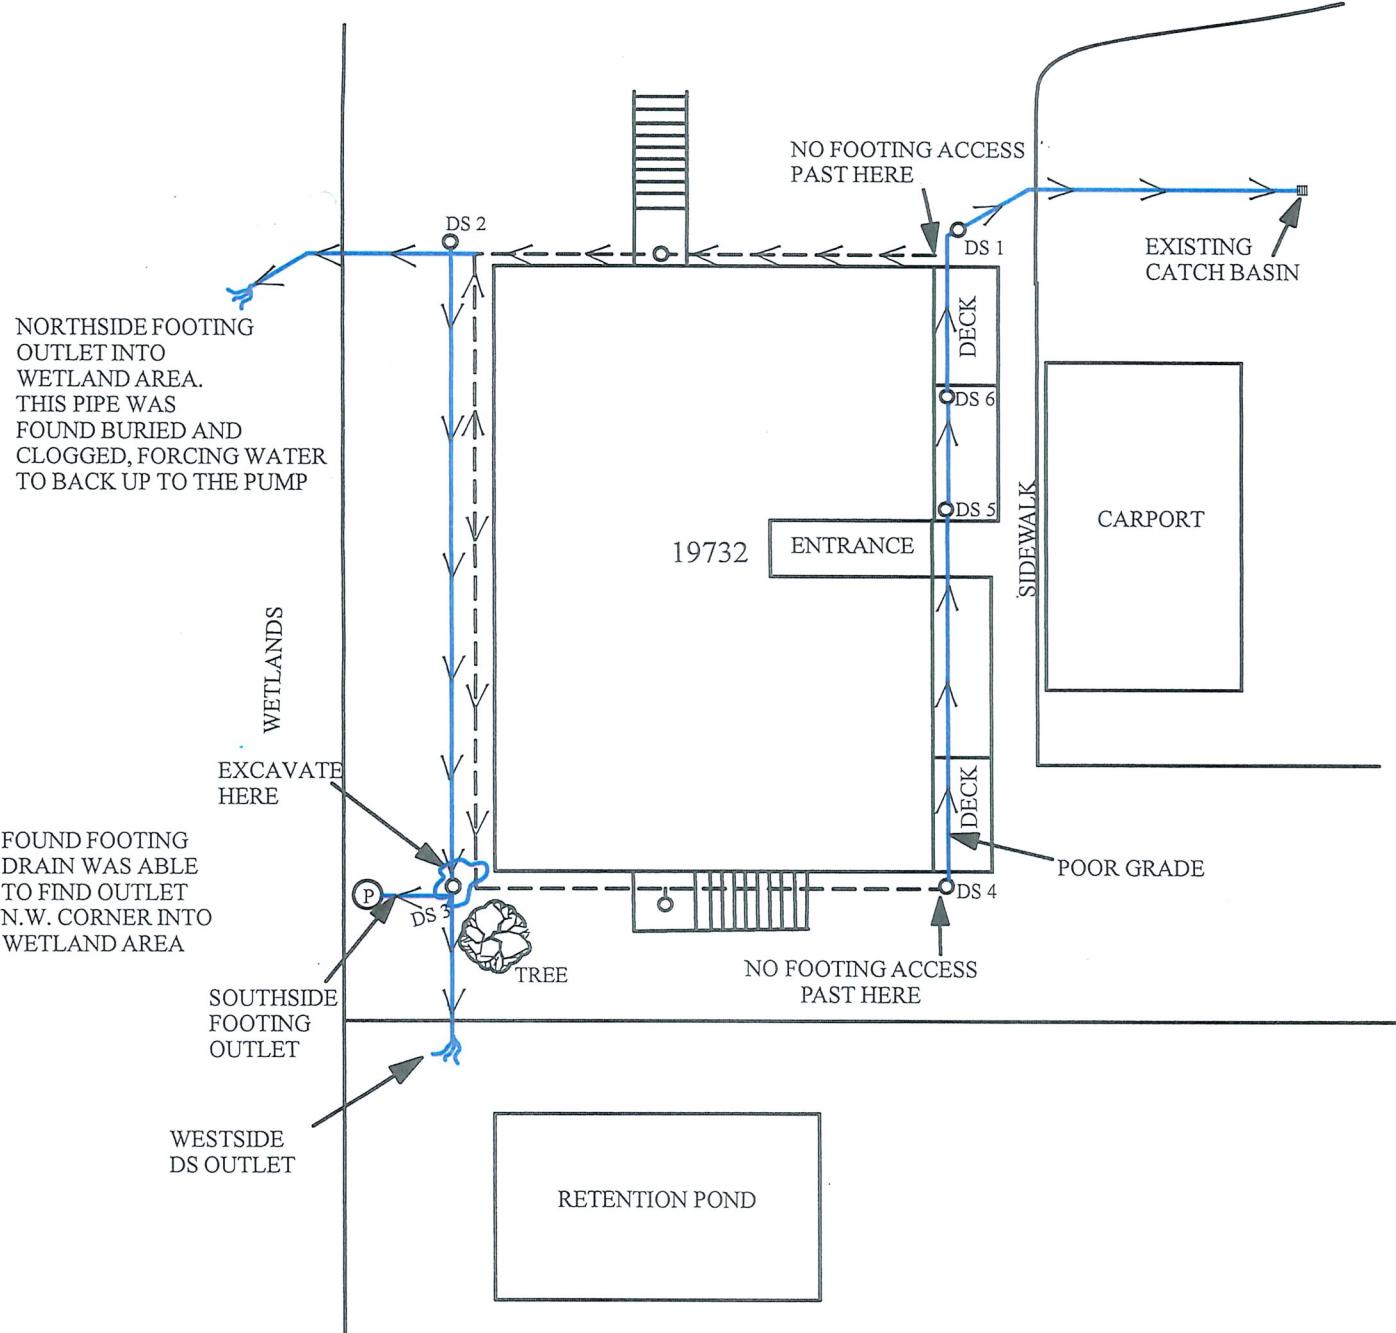
Good news, we found the foundation/footing drain, 2 directions, one to the pump, one to the wetland area. Appears footing foundation drain at South side was also directed to the wetland area, but at some point the pump was installed.

Poor grade on Southeast side, monitor pipe depending on tree root activity.

- 1) The Wetlands outlet pipe 6" was buried obstructed with roots and has no check valve, roots were cleared and removed minor grading was done to wetland area to allow flow.
- 2) Pump for Southside footing drain pumps to wetlands and Westside of pump.

- 1) Wetland outlet was excavated with trough to drain better during site visit. Add a check valve to prevent water from going back into the buildings foundation drain.

Install dual pump system in existing pump vault on the Westside of the property, this would include an alarm. New outlet pipe from pump to be directed to retention pond, not wetland area.
