PARK PLACE HOMES
19726-19732 50th Avenue West,
Lynnwood, WA 98036

**BUILDING JOINT INTRUSIVE
INVESTIGATION FINDINGS
REPORT**

June 11, 2025

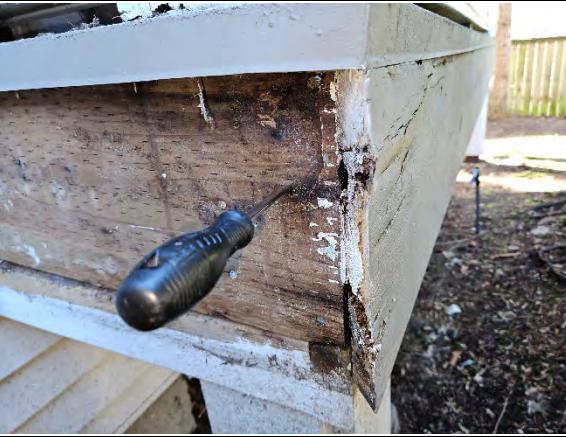
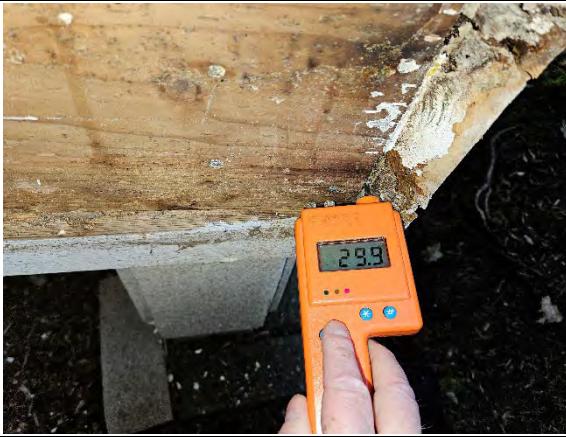
Photo 1.9: Water damaged deck framing.	Photo 1.10: Wet reading (29.9) at deck framing.

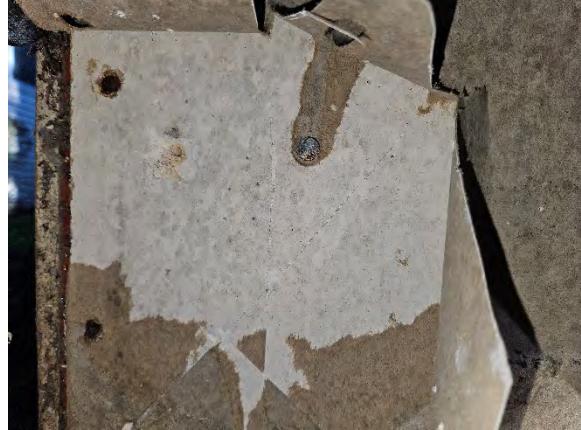
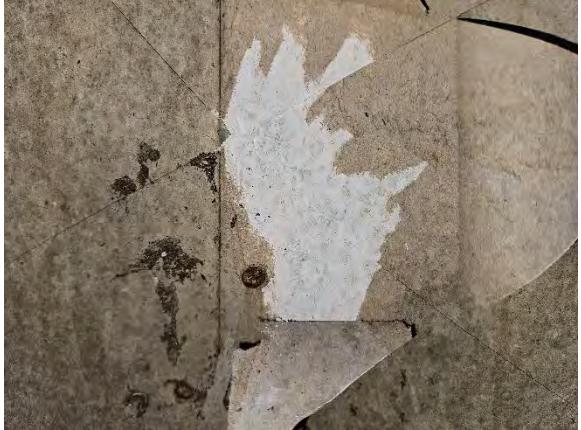
Photo 3.3: Water damaged gypsum sheathing, paper facing, and fasteners.	Photo 3.4: Water damaged gypsum sheathing, paper facing, and fasteners.

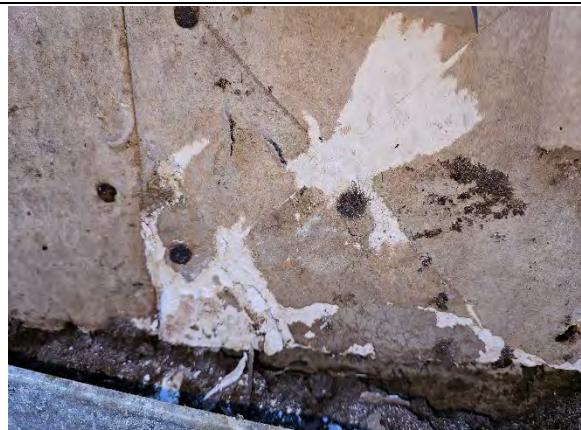
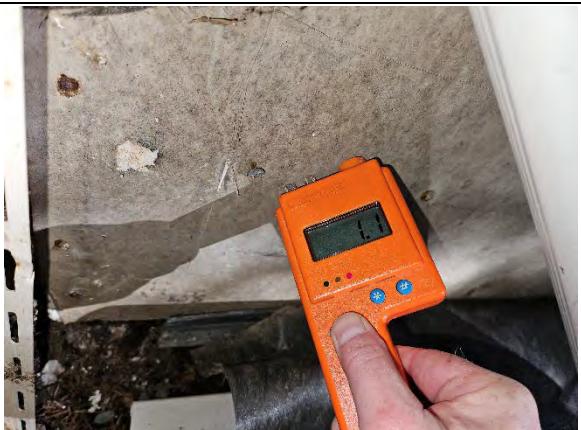
Photo 3.5: Water damaged gypsum sheathing, paper facing, fasteners, and core.	Photo 3.6: Wet reading (1.1) at gypsum sheathing.

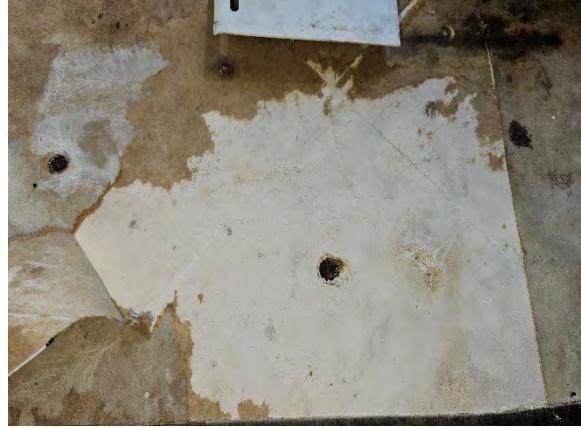
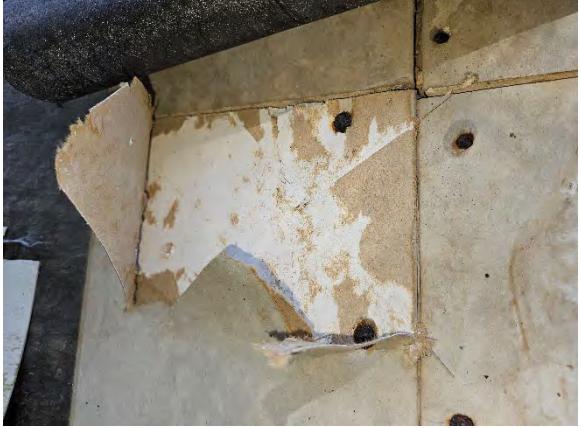
Photo 5.3: Water damaged gypsum sheathing, paper facing, and fasteners.	Photo 5.4: Water damaged gypsum sheathing, paper facing, and fasteners.

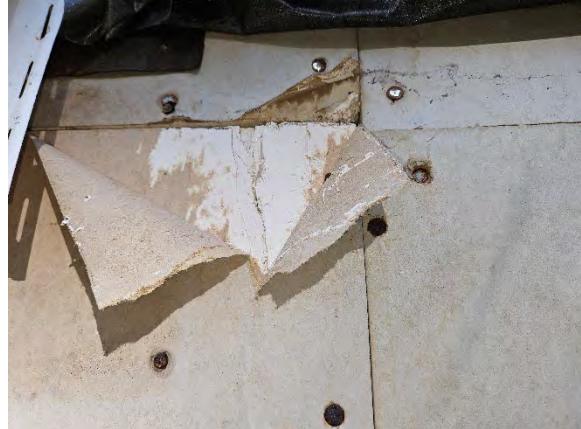
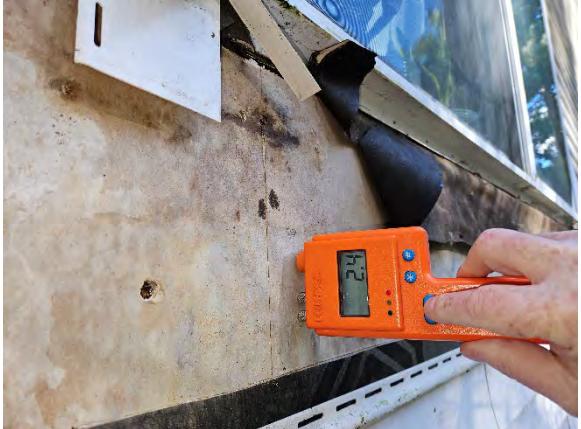
Photo 5.5: Water damaged gypsum sheathing, paper facing, fasteners, and core.	Photo 5.6: Wet reading (2.4) at gypsum sheathing.

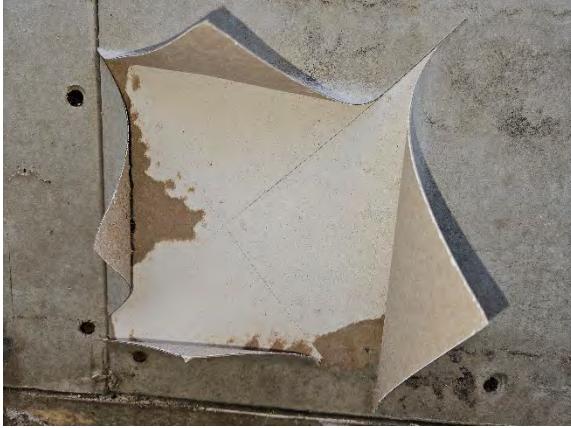
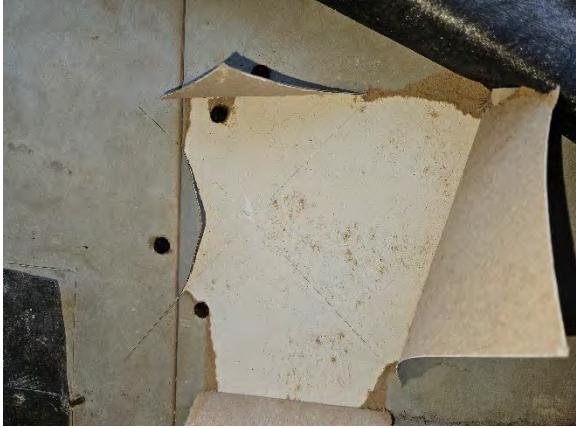
Photo 6.3: Water damaged gypsum sheathing, paper facing, and fasteners.	Photo 6.4: Water damaged gypsum sheathing, paper facing, and fasteners.

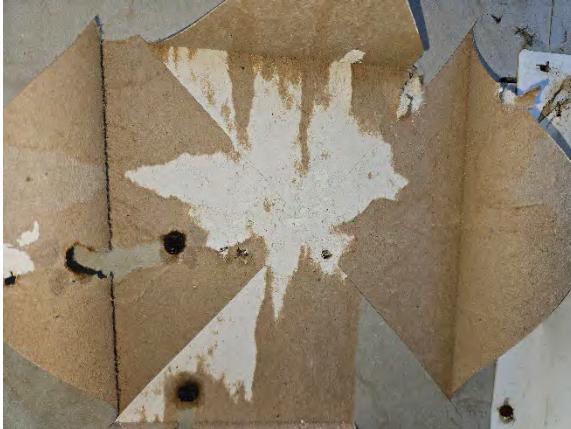
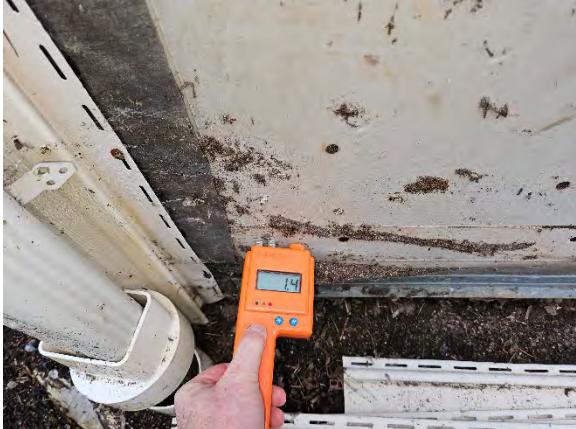
Photo 6.5: Water damaged gypsum sheathing, paper facing, and fasteners.	Photo 6.6: Wet reading (1.4) at gypsum sheathing.

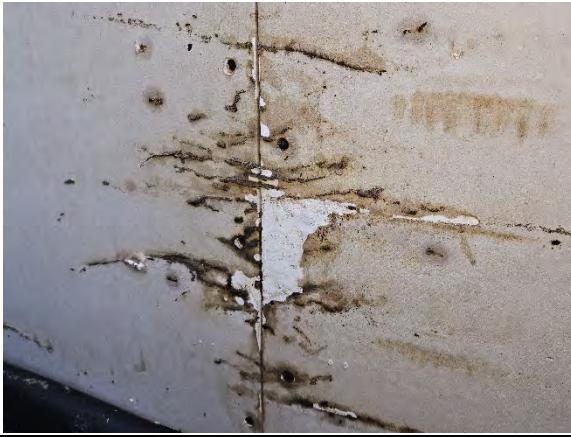
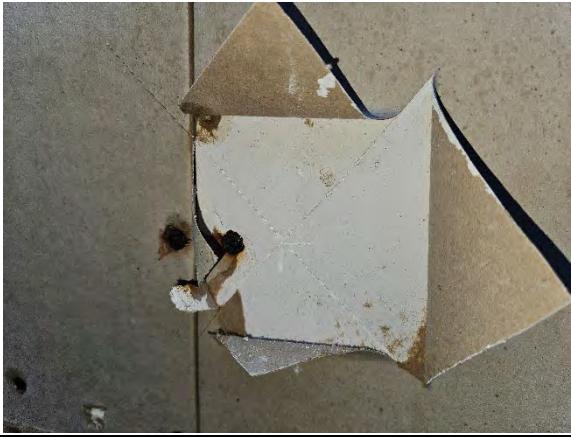
Photo 1.5: Water damaged gypsum sheathing, paper facing, fasteners, and core.	Photo 1.6: Water damaged gypsum sheathing, paper facing, and fasteners.

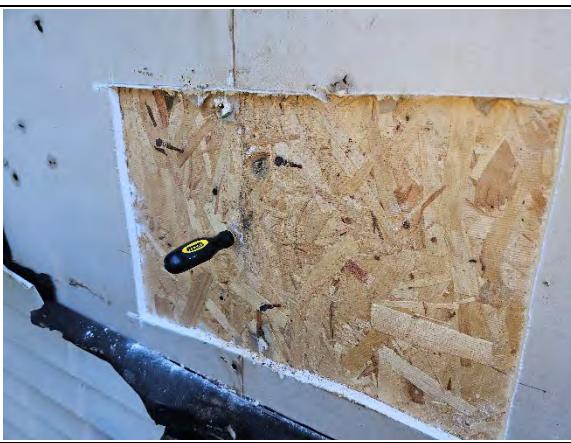
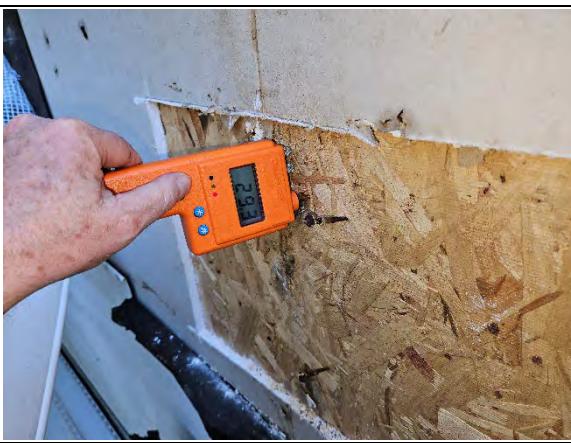
Photo 1.9: Water damaged OSB sheathing.	Photo 1.10: Wet reading (29.3) at OSB sheathing.

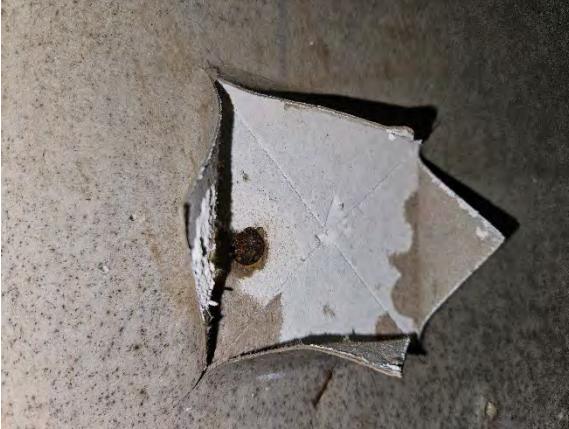
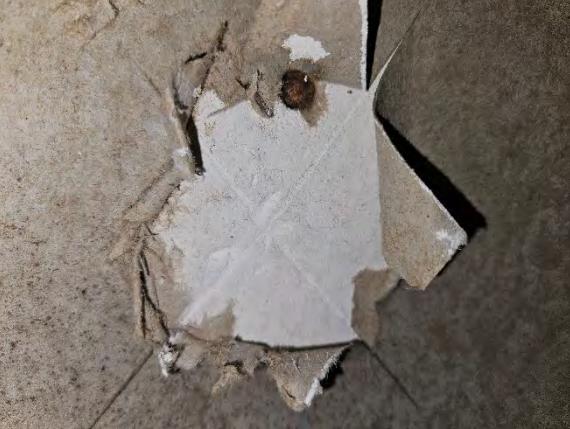
Photo 2.5: Water damaged gypsum sheathing, paper facing, fasteners, and core.	Photo 2.6: Water damaged gypsum sheathing, paper facing, and fasteners.

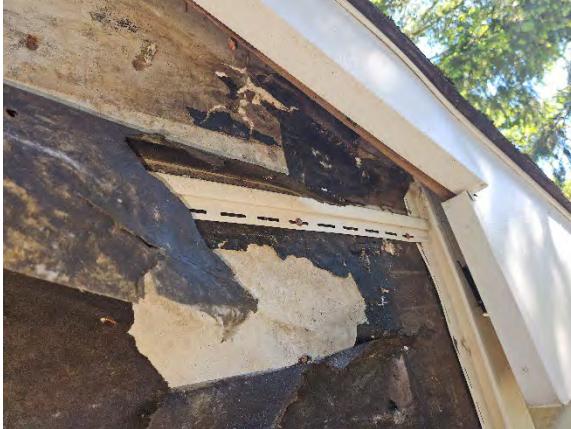
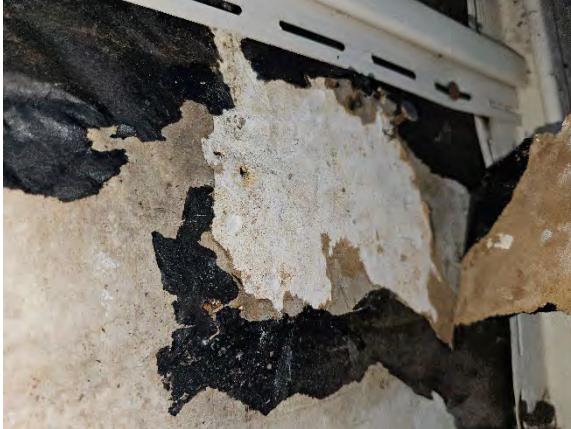
Photo 3.3: Water damaged WRB.	Photo 3.4: Water damaged WRB.

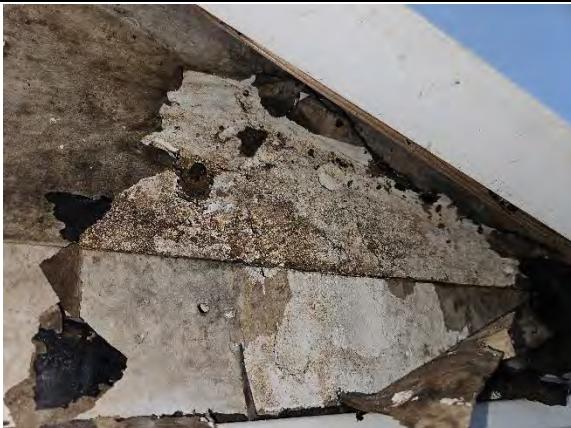
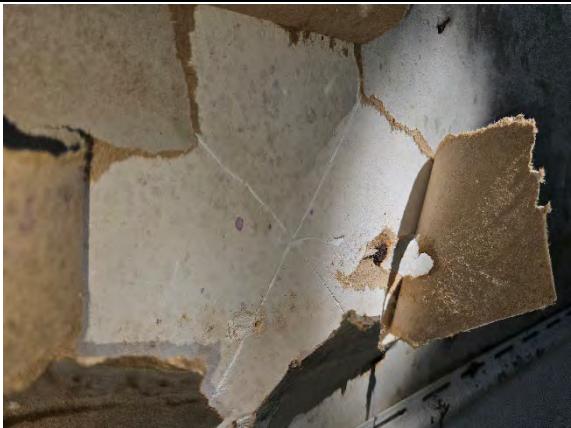
Photo 3.5: Water damaged gypsum sheathing, paper facing, fasteners, and core.	Photo 3.6: Water damaged gypsum sheathing, paper facing, and fasteners.

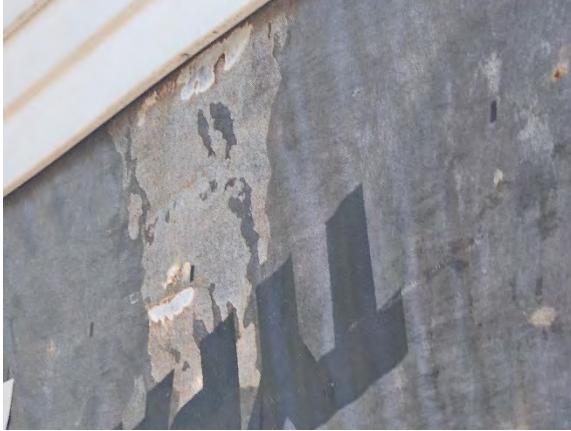
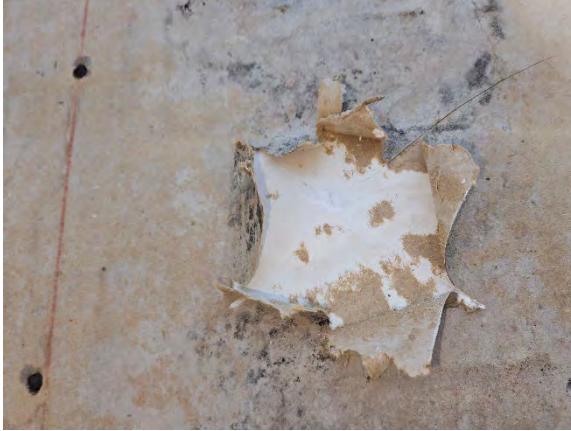
Photo 4.3: Water damaged WRB.	Photo 4.4: Water damaged gypsum sheathing, paper facing, and fasteners.

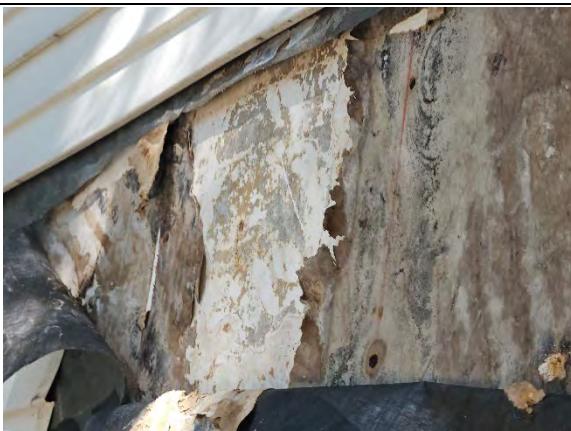
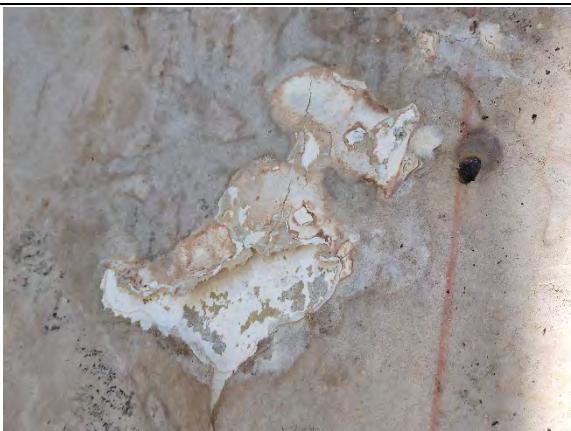
Photo 4.5: Water damaged gypsum sheathing, paper facing, fasteners, and core.	Photo 4.6: Water damaged gypsum sheathing, paper facing, fasteners, and core.

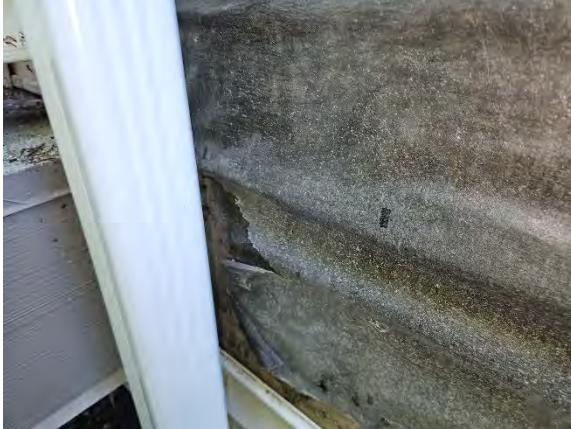
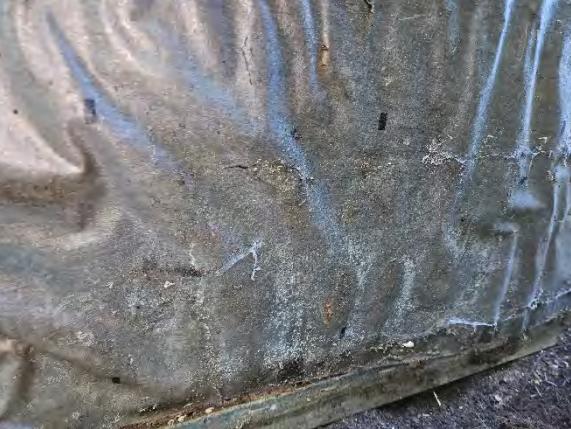
Photo 5.3: Water damaged WRB.	Photo 5.4: Water damaged WRB.

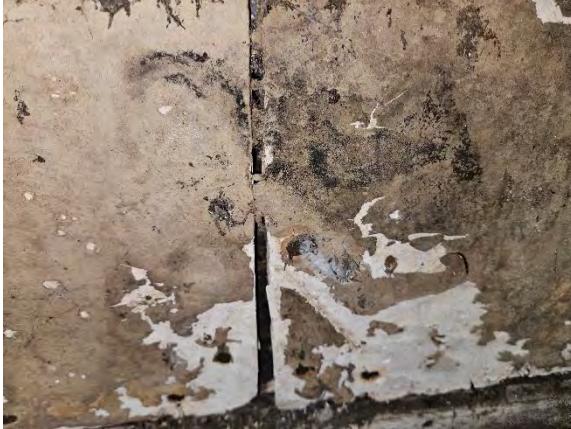
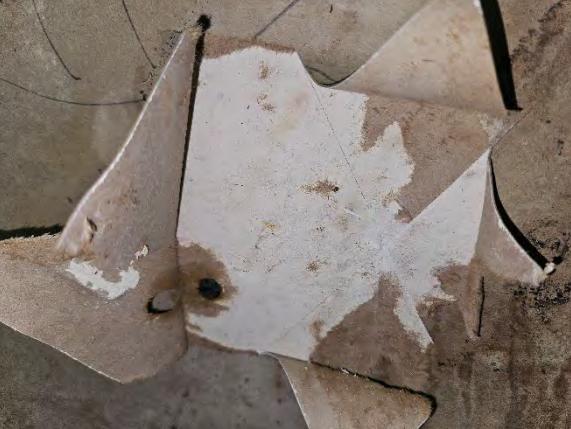
Photo 5.5: Water damaged gypsum sheathing, paper facing, fasteners, and core.	Photo 5.6: Water damaged gypsum sheathing, paper facing, fasteners, and core.

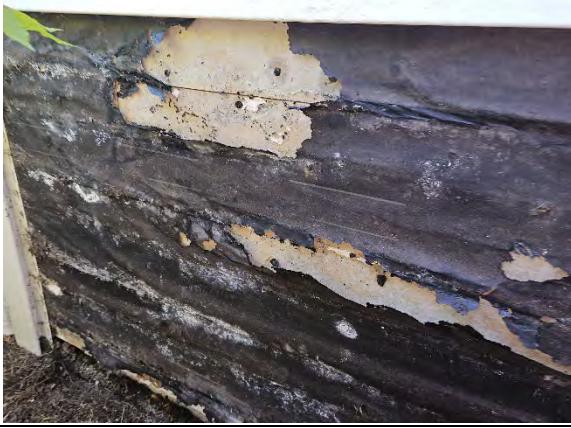
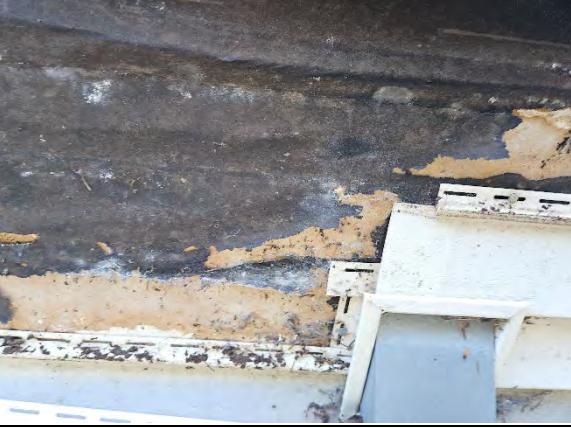
Photo 8.3: Water damaged WRB.	Photo 8.4: Water damaged WRB.

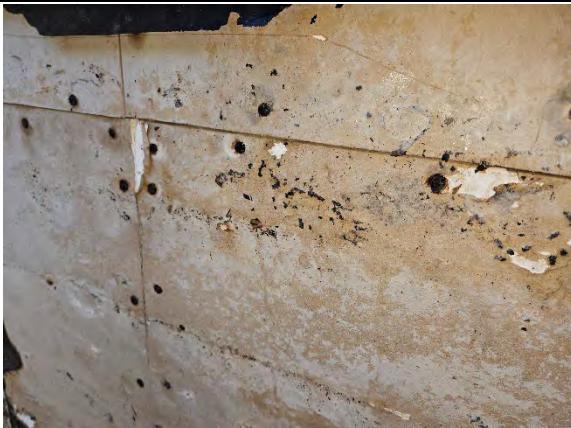
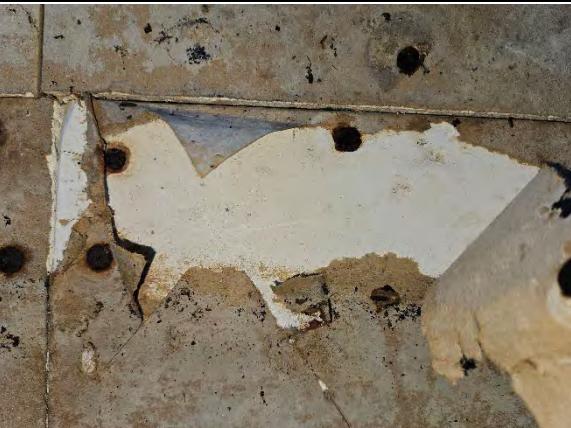
Photo 8.5: Water damaged gypsum sheathing, paper facing, fasteners, and core.	Photo 8.6: Water damaged gypsum sheathing, paper facing, fasteners, and core.

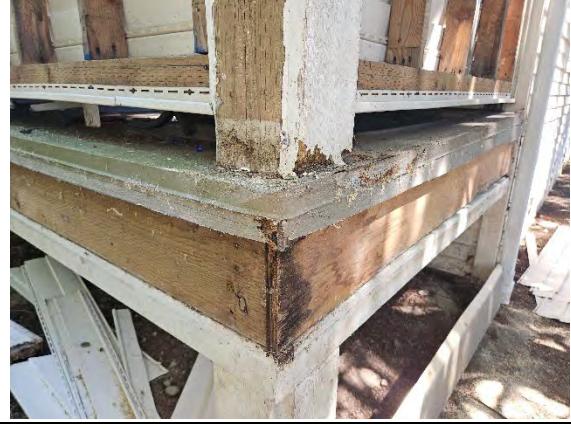
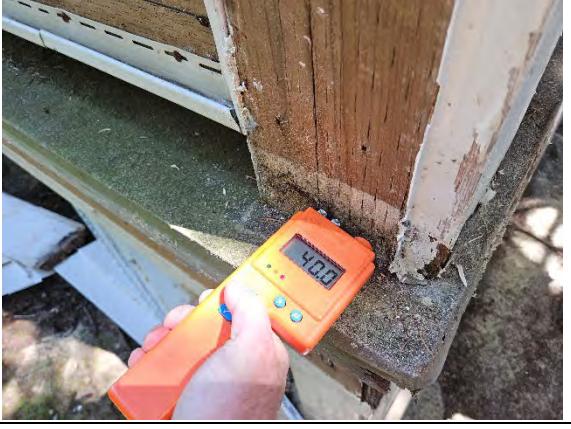
Photo 10.3: Water damaged deck framing.	Photo 10.4: Maximum reading (40.0) at deck column.

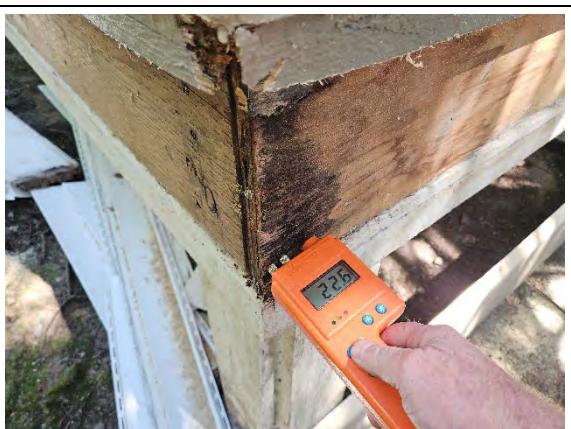
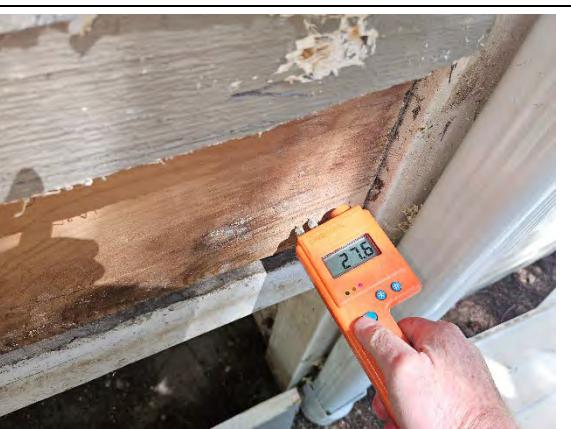
Photo 10.5: Wet reading (22.6) at deck framing.	Photo 10.6: Wet reading (27.6) at deck framing.

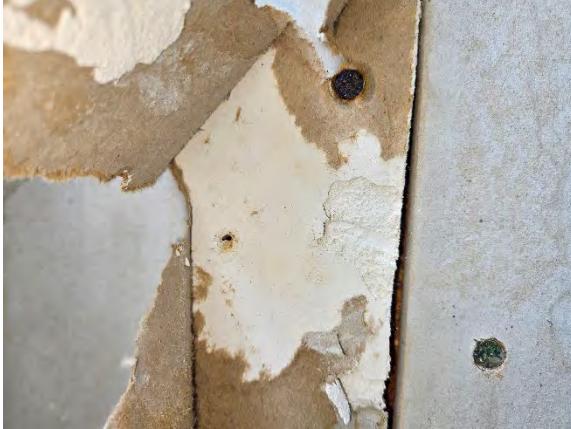
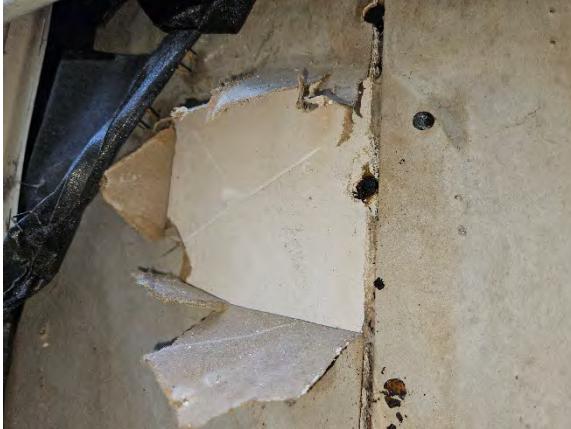
Photo 11.3: Water damaged gypsum sheathing, paper facing, fasteners, and core.	Photo 11.4: Water damaged gypsum sheathing, paper facing, fasteners, and core.

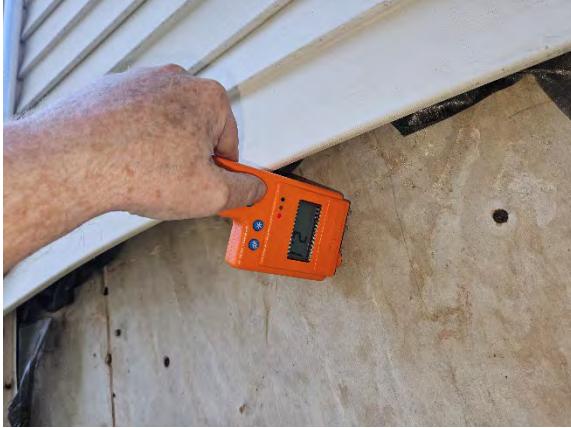
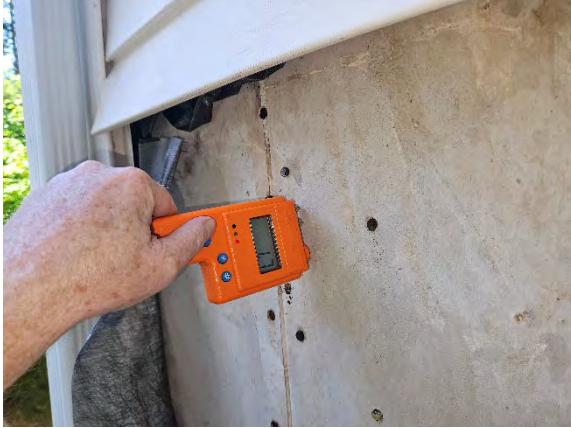
Photo 11.5: Wet reading (2.1) at gypsum sheathing.	Photo 11.6: Wet reading (1.7) at gypsum sheathing.

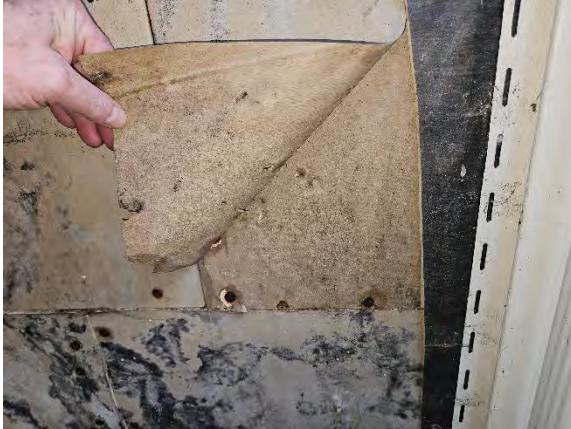
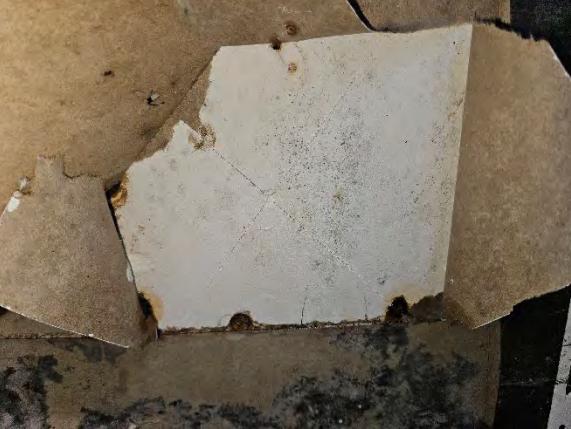
Photo 12.3: Water damaged gypsum sheathing, paper facing, fasteners, and core.	Photo 12.4: Water damaged gypsum sheathing, paper facing, fasteners, and core.

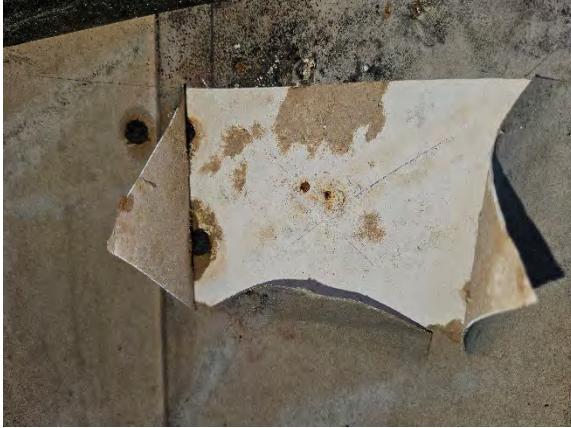
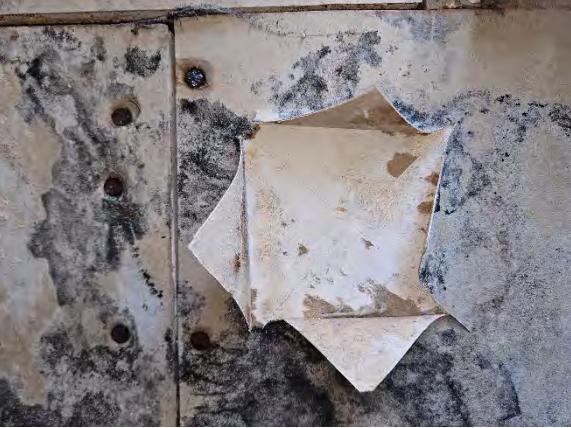
Photo 12.5: Water damaged gypsum sheathing, paper facing, fasteners, and core.	Photo 12.6: Water damaged gypsum sheathing, paper facing, and fasteners.

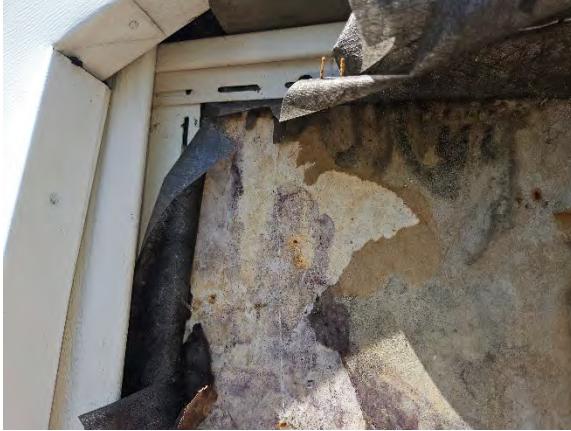
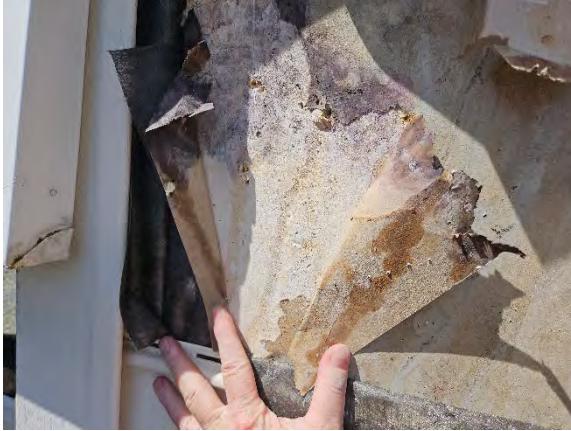
Photo 13.3: Water damaged gypsum sheathing, paper facing, fasteners, and core.	Photo 13.4: Water damaged gypsum sheathing, paper facing, fasteners, and core.

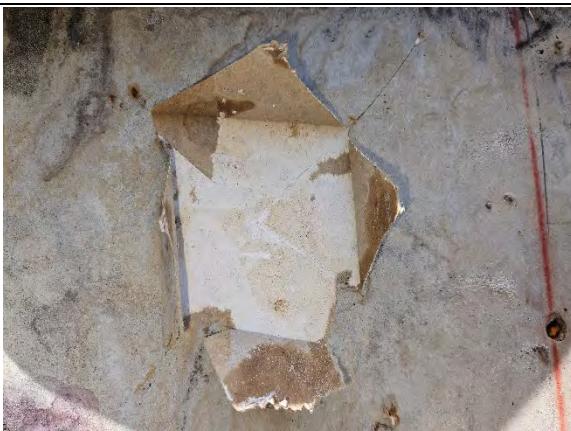
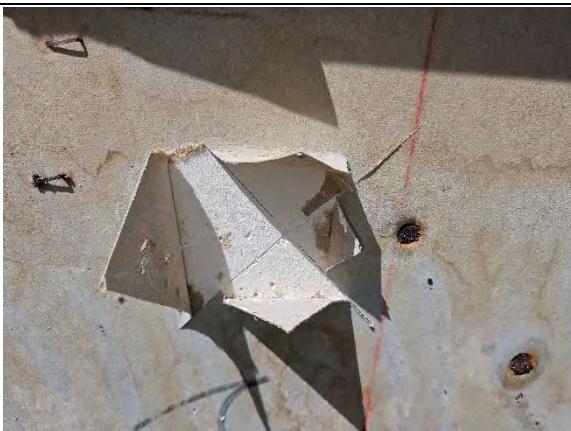
Photo 13.5: Water damaged gypsum sheathing, paper facing, and fasteners.	Photo 13.6: Water damaged gypsum sheathing, paper facing, and fasteners.

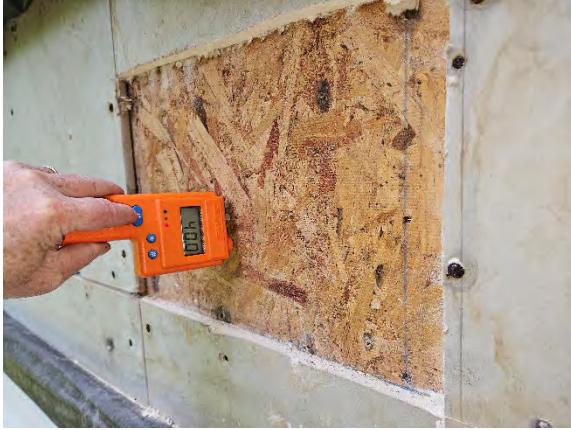
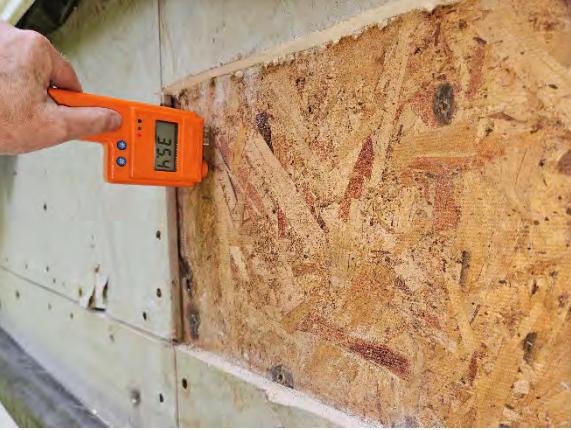
Photo 14.7: Maximum reading (40.0) at OSB sheathing.	Photo 14.8: Wet reading (35.4) at OSB sheathing.

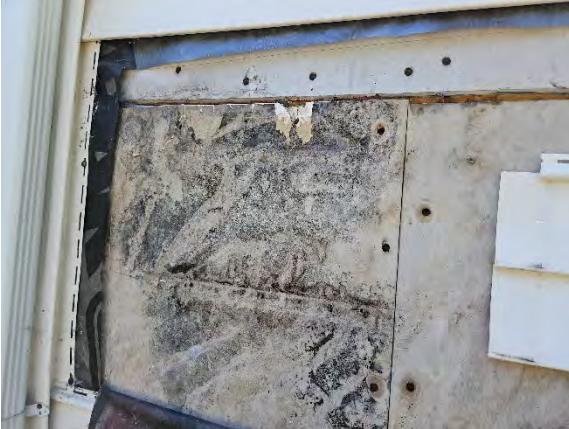
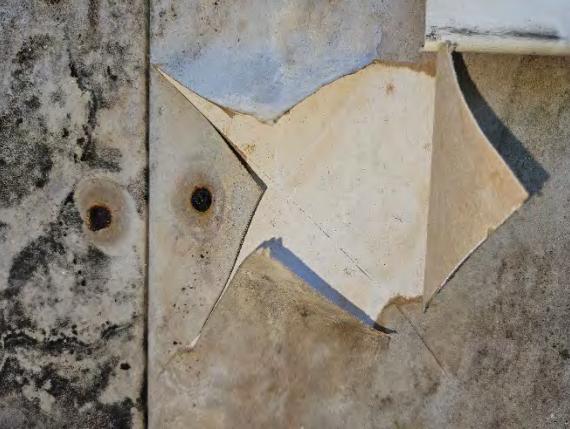
Photo 15.3: Water damaged gypsum sheathing, paper facing, and fasteners.	Photo 15.4: Water damaged gypsum sheathing, paper facing, and fasteners.

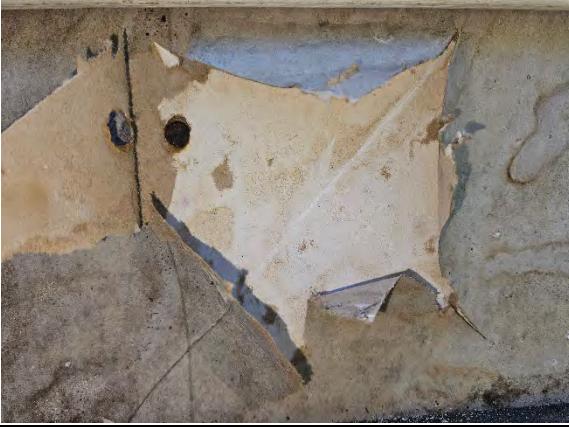
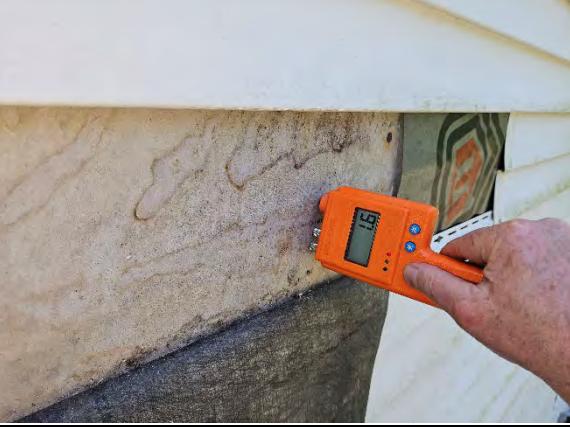
Photo 15.5: Water damaged gypsum sheathing, paper facing, and fasteners.	Photo 15.6: Wet reading (1.6) at gypsum sheathing.

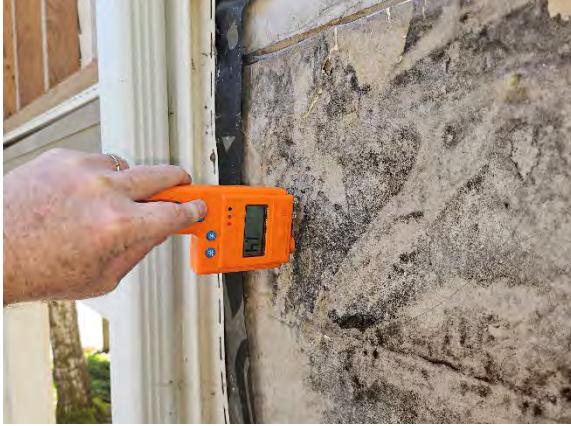
Photo 15.7: Wet reading (1.4) at gypsum sheathing.	Photo 15.8: Water damaged OSB sheathing.

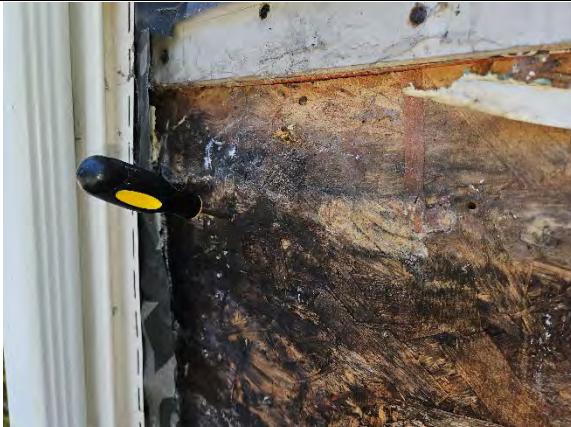
Photo 15.9: Water damaged OSB sheathing.	Photo 15.10: Water damaged OSB sheathing.

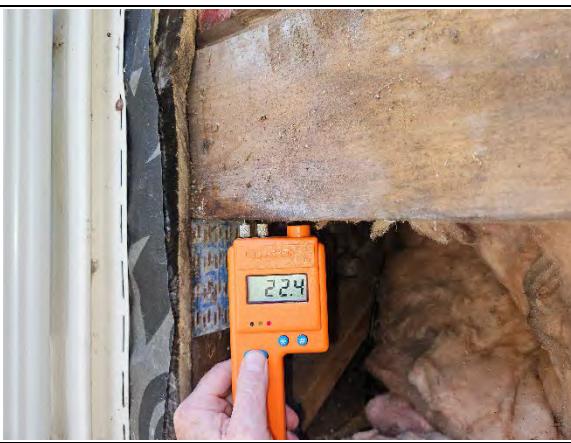
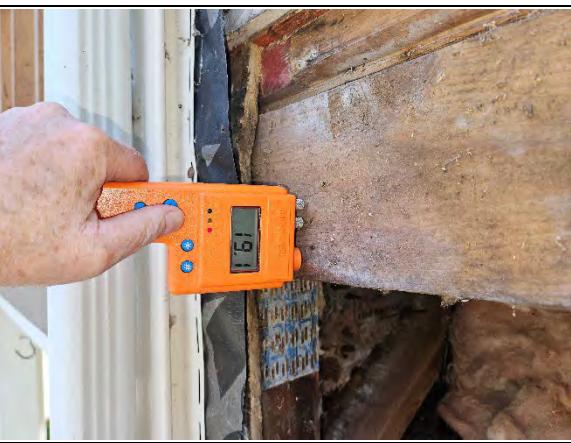
Photo 15.15: Wet reading (22.4) at framing.	Photo 15.16: Wet reading (19.1) at framing.

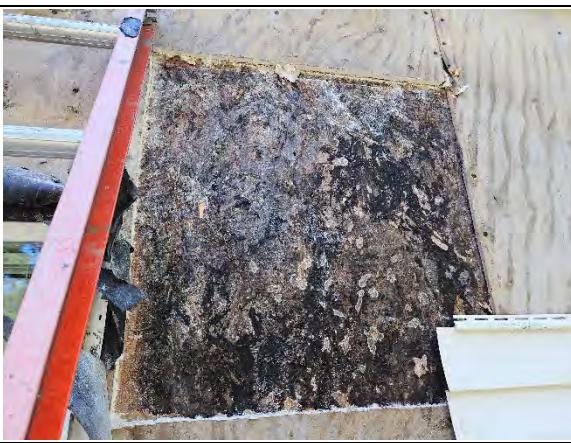
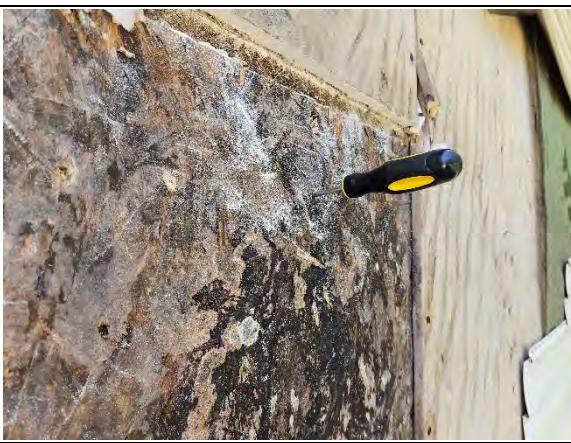
Photo 16.9: Water damaged OSB sheathing.	Photo 16.10: Water damaged OSB sheathing.

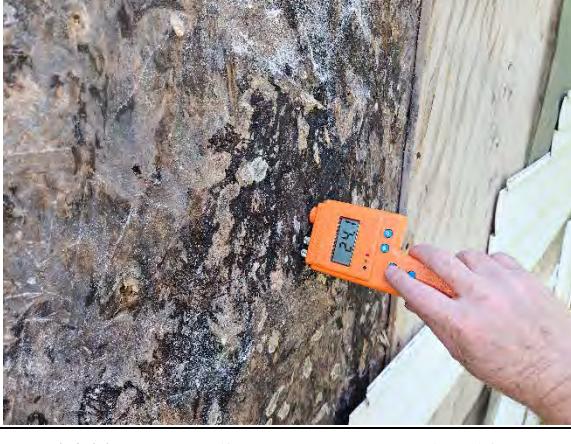
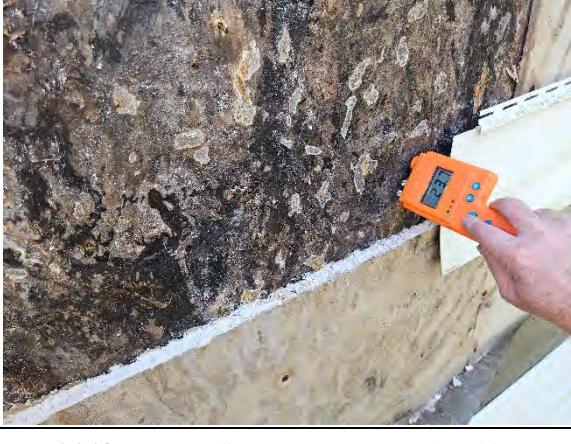
Photo 16.11: Wet reading (24.1) at OSB sheathing.	Photo 16.12: Wet reading (23.7) at OSB sheathing.

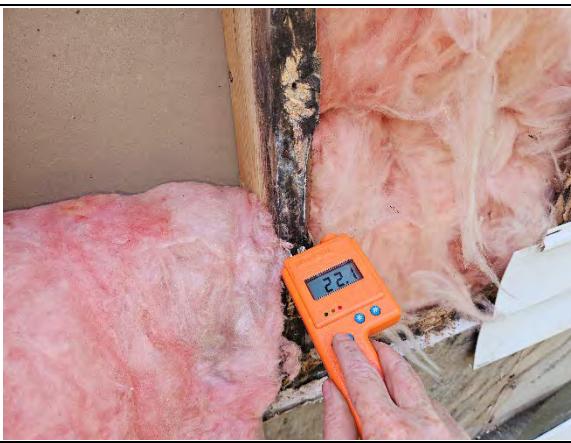
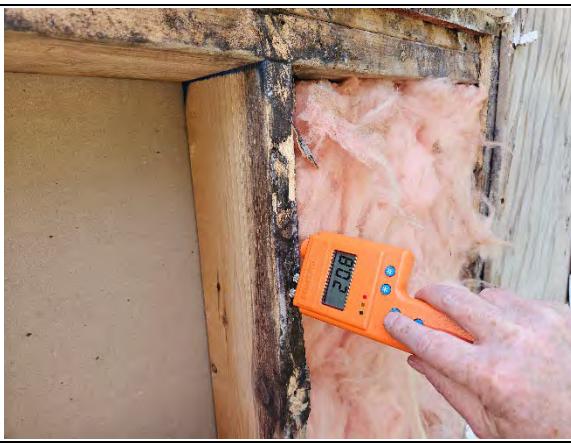
Photo 16.15: Wet reading (22.1) at framing.	Photo 16.16: Wet reading (20.8) at framing.
