Park Place Condominium Lynnwood, WA

Report #: 38175-1
Beginning: January 1, 2024
Expires: December 31, 2024

**RESERVE STUDY
Update "No-Site-Visit"**

July 16, 2023

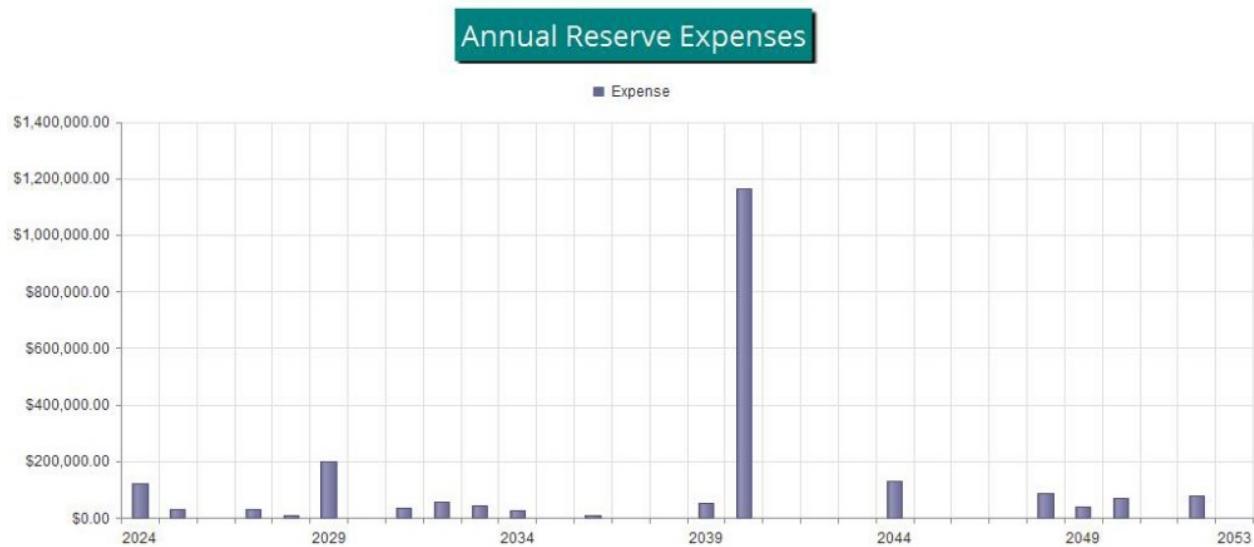
Figure 1

The figure below summarizes the projected future expenses at your association as defined by your Reserve Component List. A summary of these expenses are shown in the 30-yr Summary Table, while details of the projects that make up these expenses are shown in the Cash Flow Detail Table.

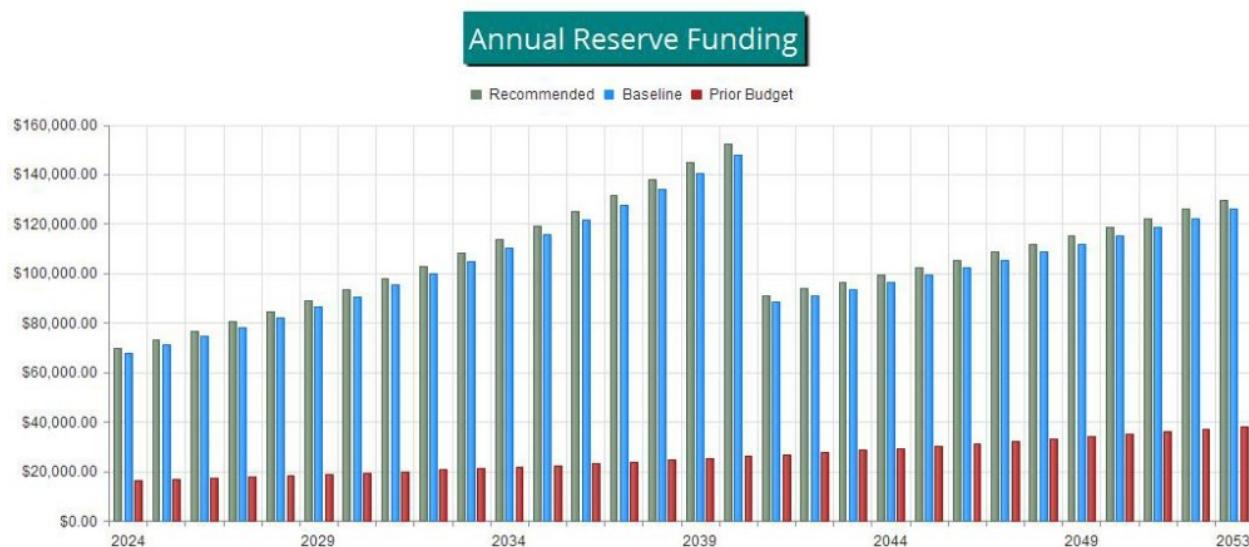
Figure 2

Based on your current Percent Funded and your near-term and long-term Reserve needs, we are recommending budgeted contributions of \$5,810 per month this Fiscal Year in addition to a special assessment*** (see note in executive summary). The overall 30-yr plan, in perspective, is shown below. This same information is shown numerically in both the 30-yr Summary Table and the Cash Flow Detail Table.

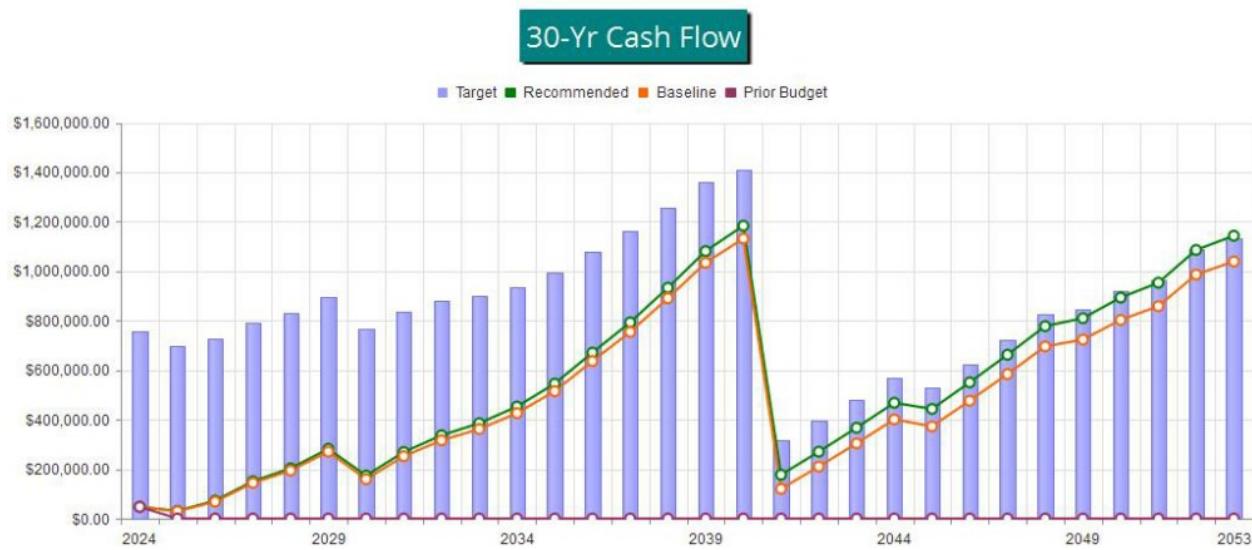
Figure 3

The following chart shows your Reserve balance under our recommended Full Funding Plan, an alternate Baseline Funding Plan, and at your current budgeted contribution rate (assumes future increases), compared to your always-changing Fully Funded Balance target.

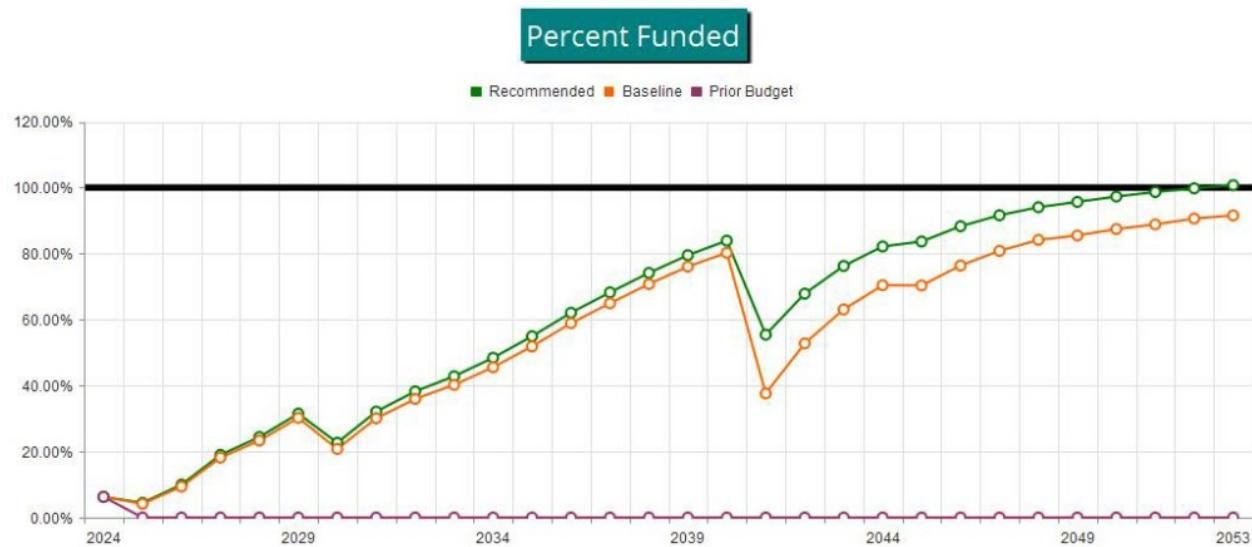
Figure 4

This figure shows the same information plotted on a Percent Funded scale. It is clear here to see how your Reserve Fund strength approaches the 100% Funded level under our recommended multi-yr Funding Plan.
