## **Park Place Condominium Lynnwood, WA**

Report #: 38175-0  
Beginning: January 1, 2023  
Expires: December 31, 2023

**RESERVE STUDY  
"Full"**

July 20, 2022

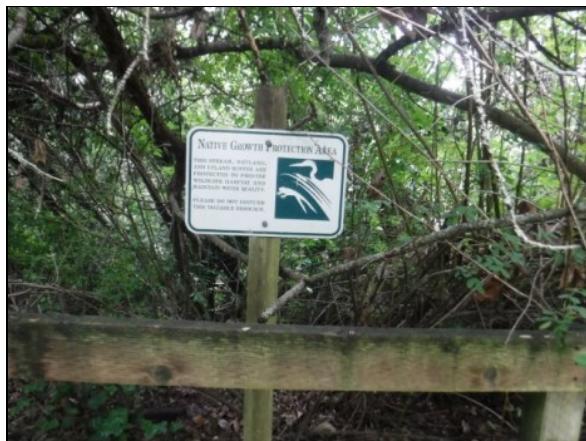
Comments: Native growth areas are typically a low maintenance item, as they are designed to be left permanently undisturbed in a substantially natural state. Plat map notes indicate that NGPA at West end of property is the maintenance responsibility of Lynnwood.

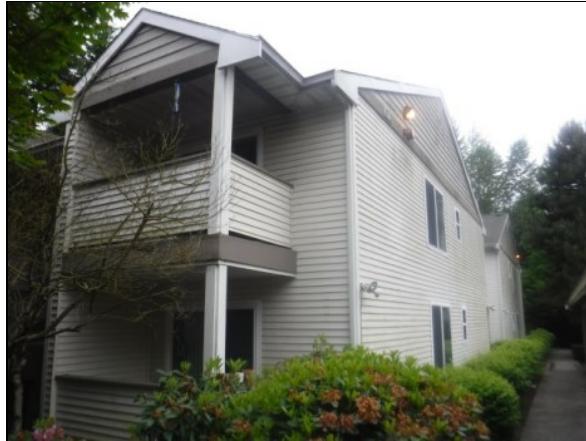
Most deck coatings come with a warranty. A typical warranty is three to five years if properly maintained. Some warranties can be extended if the re-coating, and any other prescribed maintenance, is performed within a certain time frame. Check your warranty paperwork to determine the necessary timing of recoating and maintenance.
