PARK PLACE HOMES
19726-19732 50th Avenue West,
Lynnwood, WA 98036

**BUILDING JOINT INTRUSIVE
INVESTIGATION FINDINGS
REPORT**

June 11, 2025

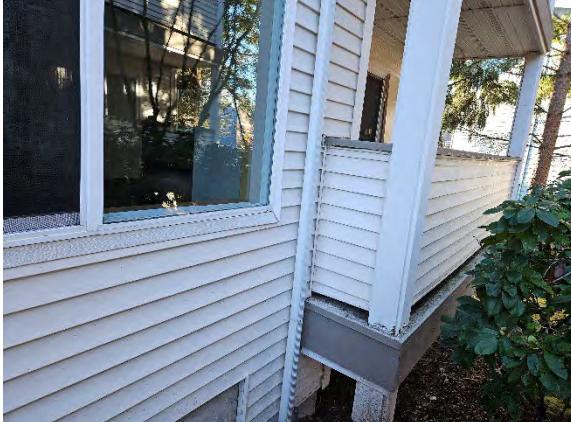
Photo 1.1: Opening Location	Photo 1.2: Opening following cladding removal.

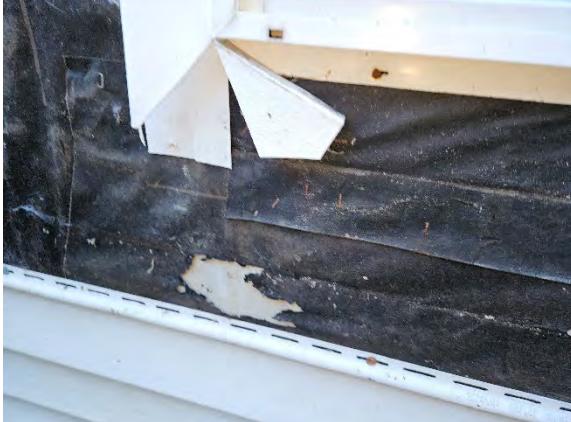
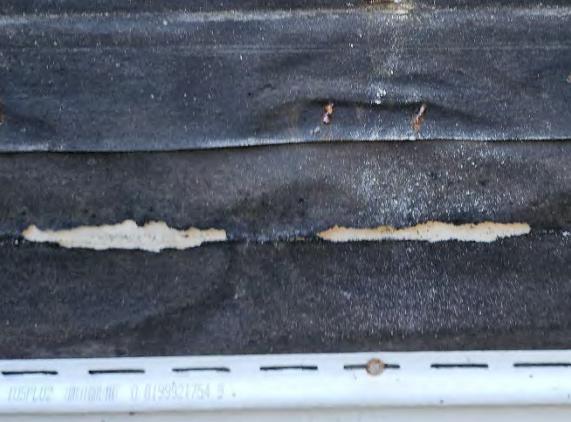
Photo 1.3: Water damaged WRB.	Photo 1.4: Water damaged WRB.

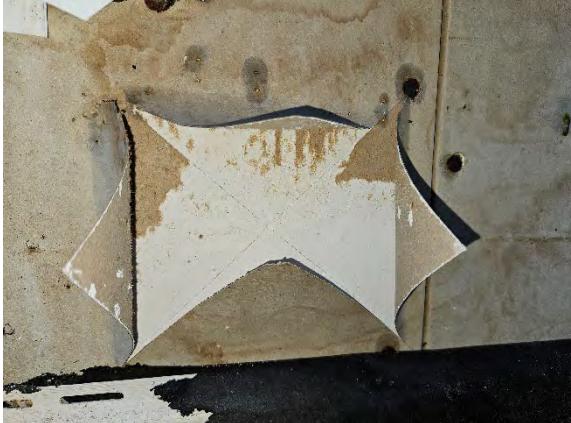
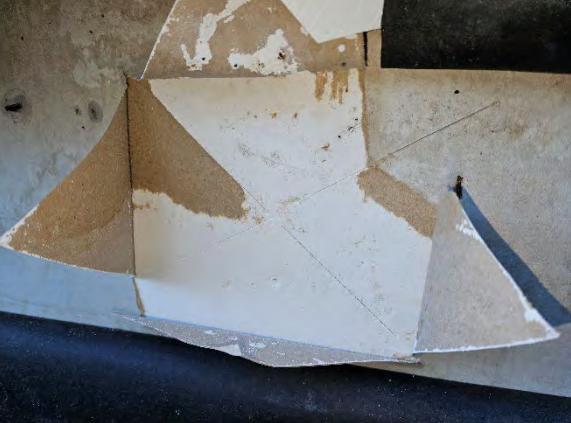
Photo 1.5: Water damaged gypsum sheathing, paper facing, and fasteners.	Photo 1.6: Water damaged gypsum sheathing, paper facing, and fasteners.

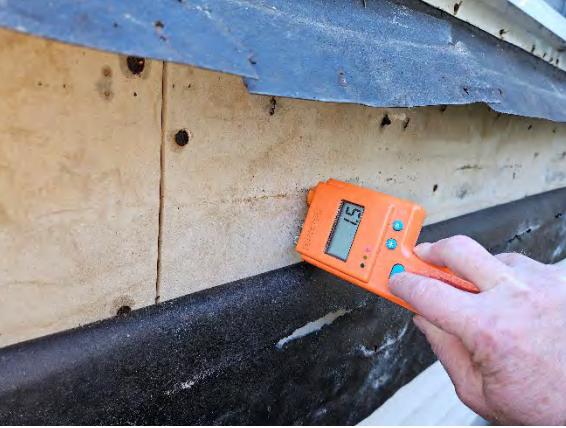
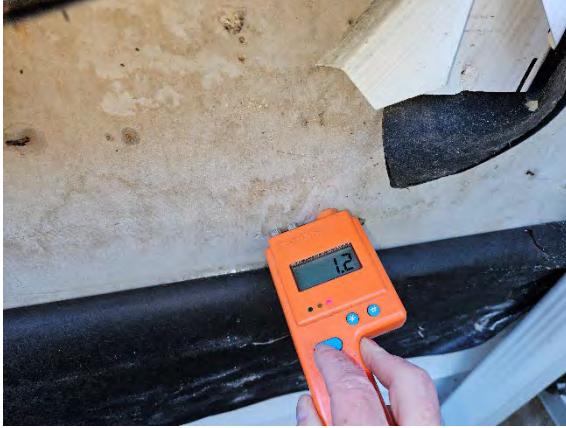
Photo 1.7: Wet reading (1.5) at gypsum sheathing.	Photo 1.8: Wet reading (1.2) at gypsum sheathing.

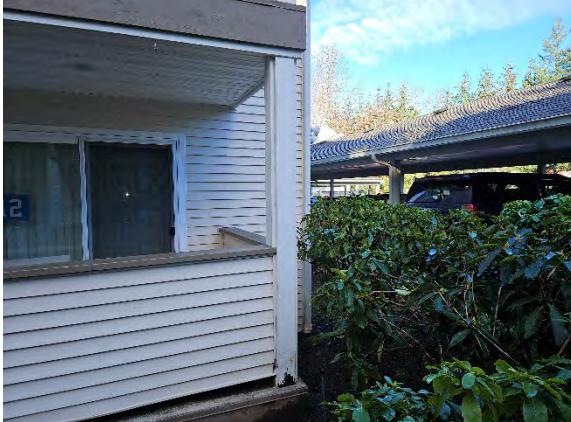
Photo 2.1: Opening Location	Photo 2.2: Opening following cladding removal.

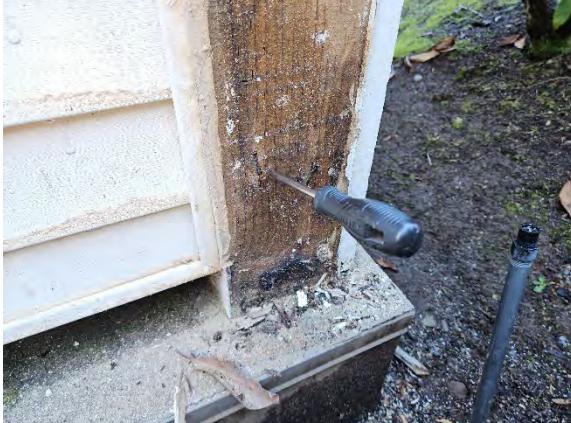
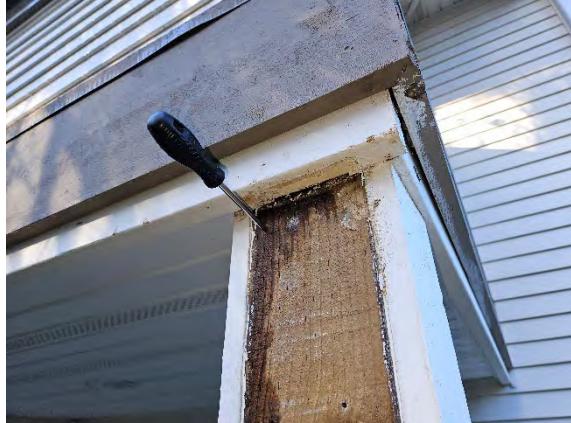
Photo 2.3: Water damaged deck column.	Photo 2.4: Water damaged deck column.

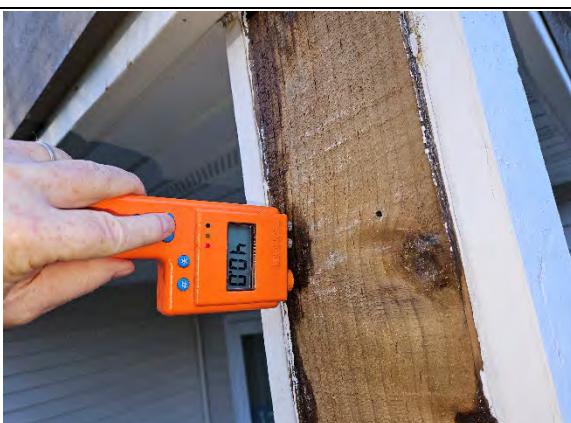
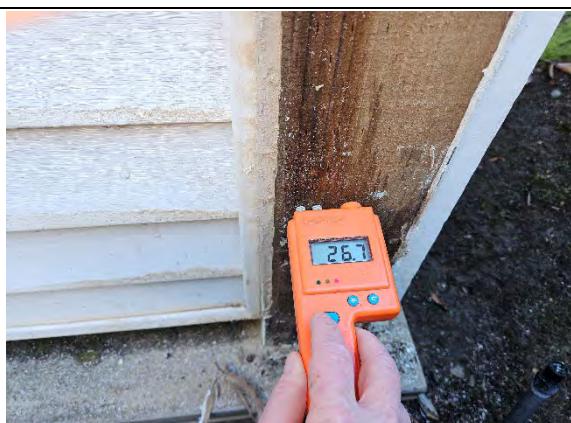
Photo 2.5: Maximum reading (40.0) at deck column.	Photo 2.6: Wet reading (26.7) at deck column.

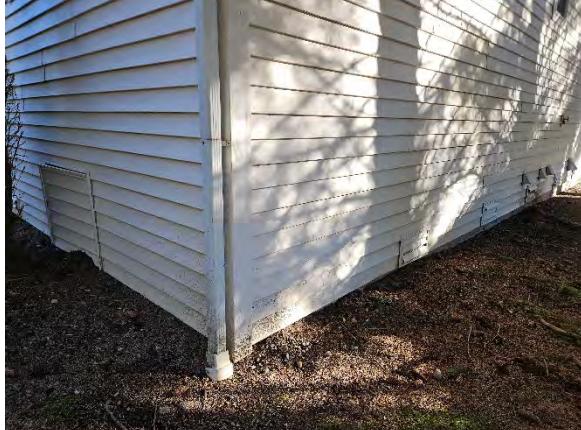
Photo 3.1: Opening Location	Photo 3.2: Opening following cladding removal.

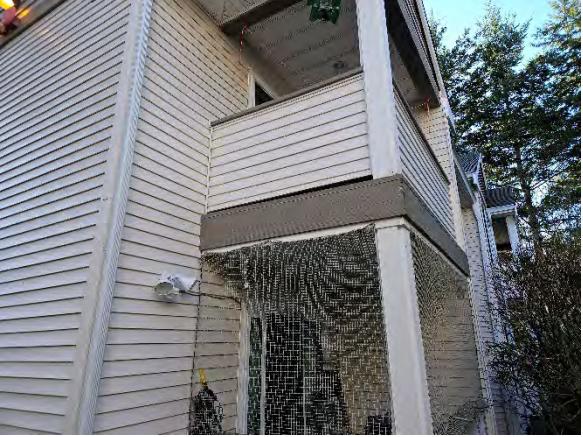
Photo 4.1: Opening Location	Photo 4.2: Opening following cladding removal.

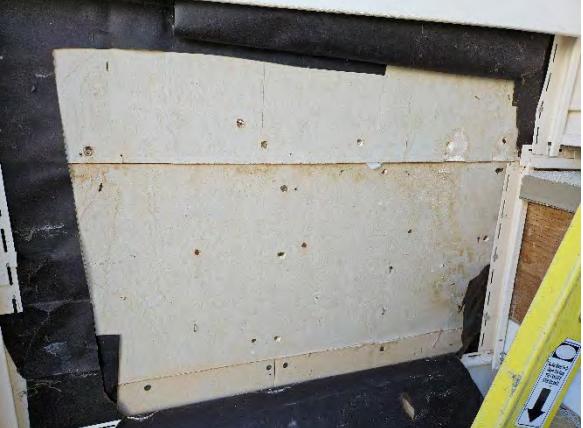
Intentionally Left Blank
Photo 4.3: Opening following WRB removal.

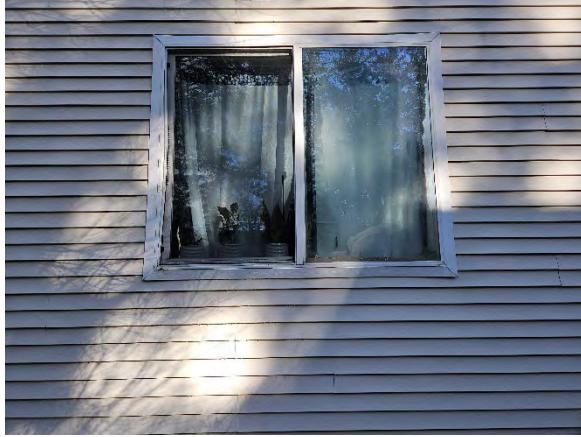
Photo 5.1: Opening Location	Photo 5.2: Opening following cladding removal.

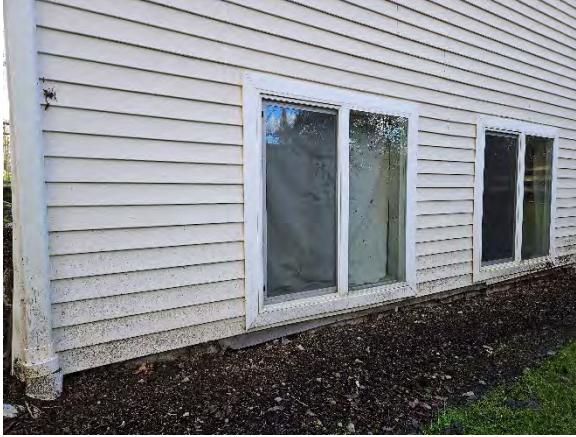
Photo 6.1: Opening Location	Photo 6.2: Opening following cladding removal.

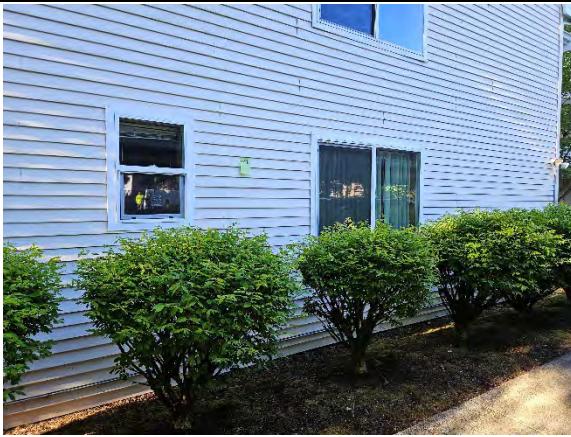
Photo 1.1: Opening Location	Photo 1.2: Opening following cladding removal.

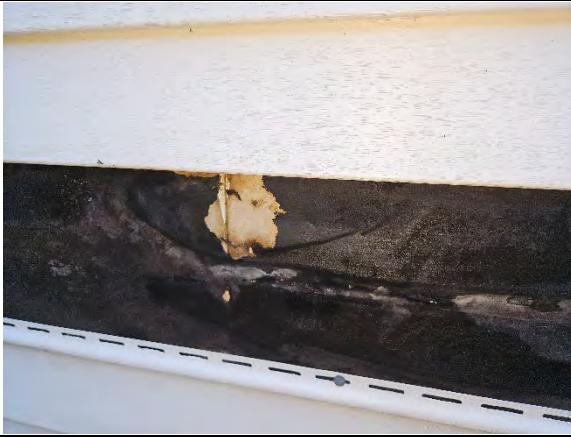
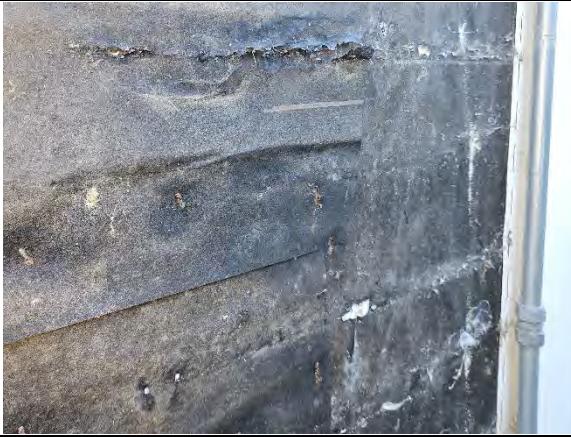
Photo 1.3: Water damaged WRB.	Photo 1.4: Water damaged WRB.

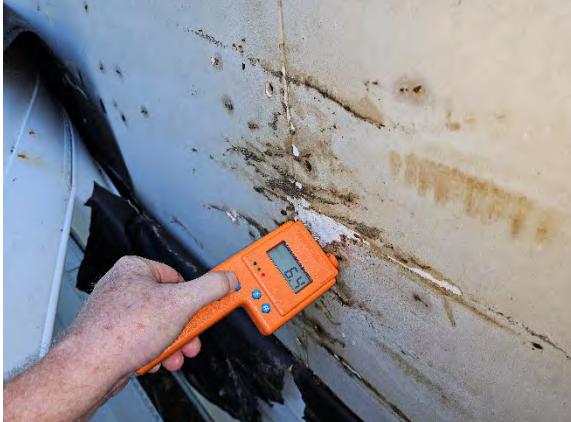
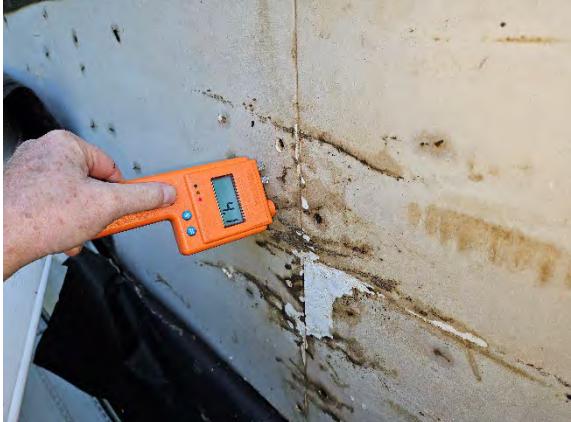
Photo 1.7: Wet reading (6.4) at gypsum sheathing.	Photo 1.8: Wet reading (4.1) at gypsum sheathing.

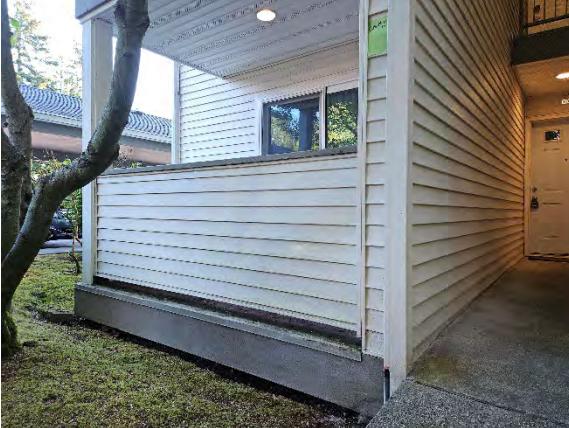
Photo 2.1: Opening Location	Photo 2.2: Opening following cladding removal.

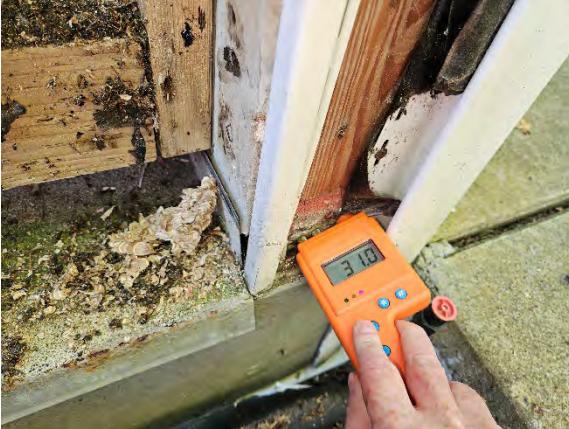
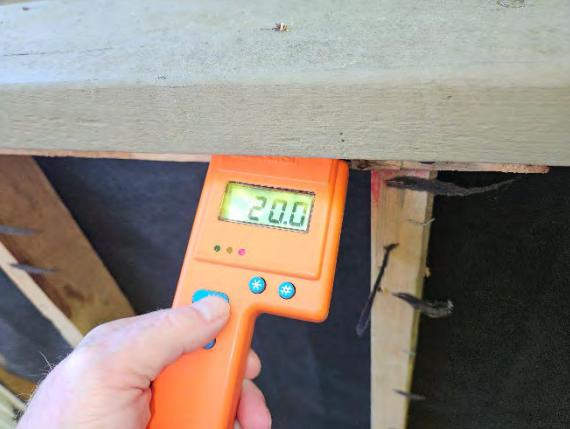
Photo 2.3: Wet reading (31.0) at framing.	Photo 2.4: Wet reading (20.0) at framing.

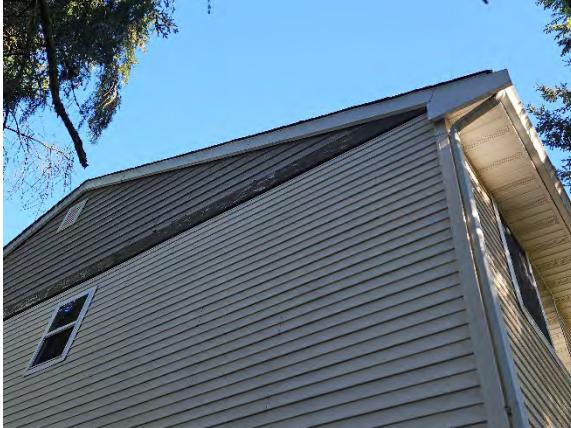
Photo 3.1: Opening Location	Photo 3.2: Opening following cladding removal.

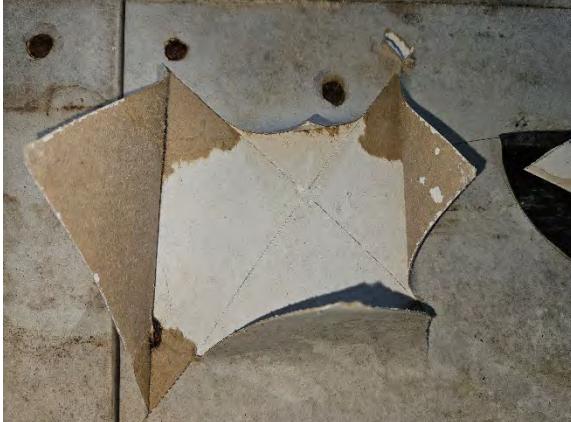
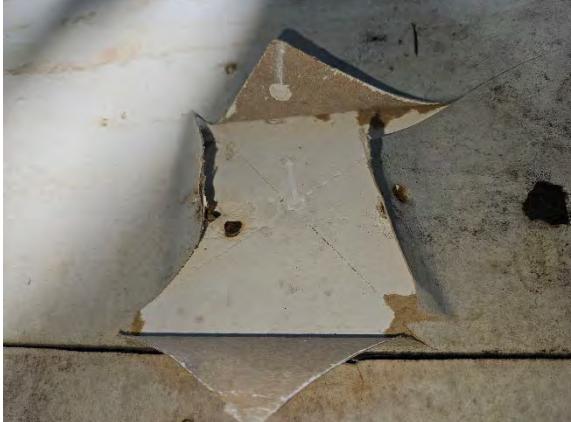
Photo 3.7: Water damaged gypsum sheathing, paper facing, and fasteners.	Photo 3.8: Water damaged gypsum sheathing, paper facing, and fasteners.

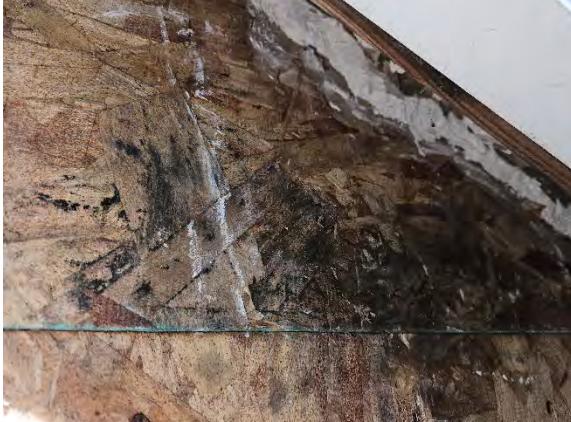
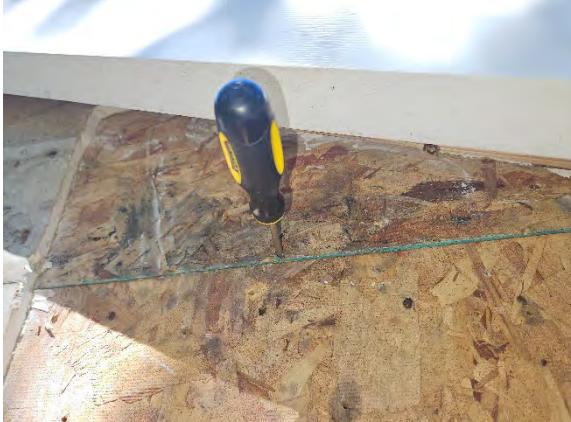
Photo 3.9: Water damaged OSB sheathing.	Photo 3.10: Water damaged OSB sheathing.

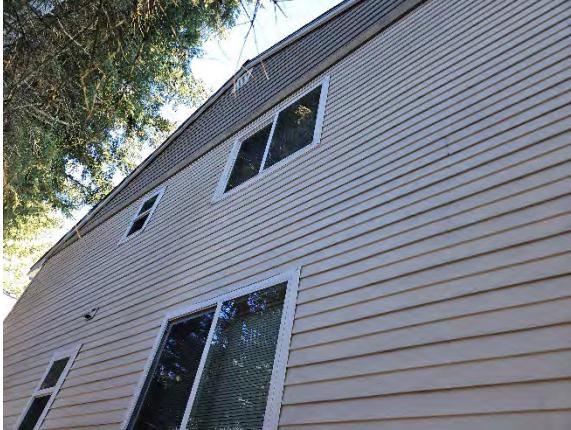
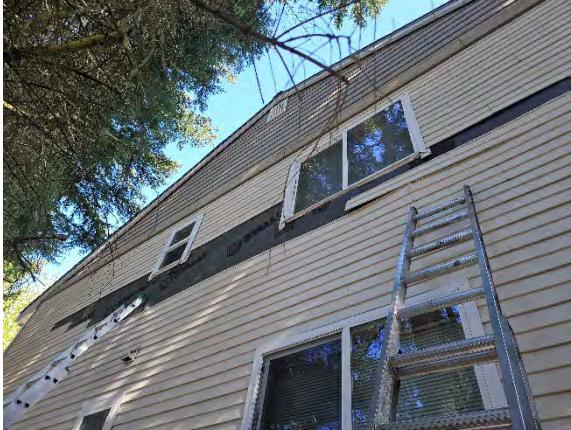
MAY 2025 OPENING 4

Photo 4.1: Opening Location	Photo 4.2: Opening following cladding removal.

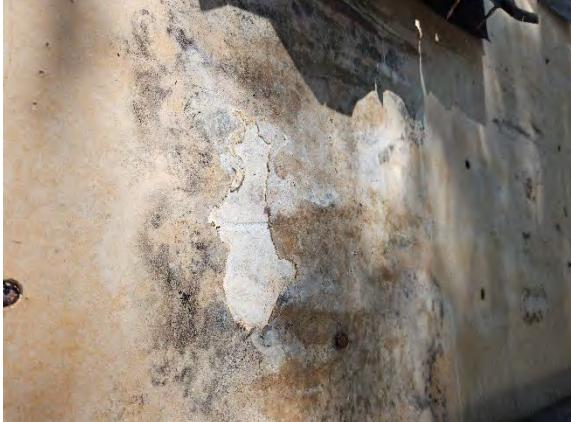
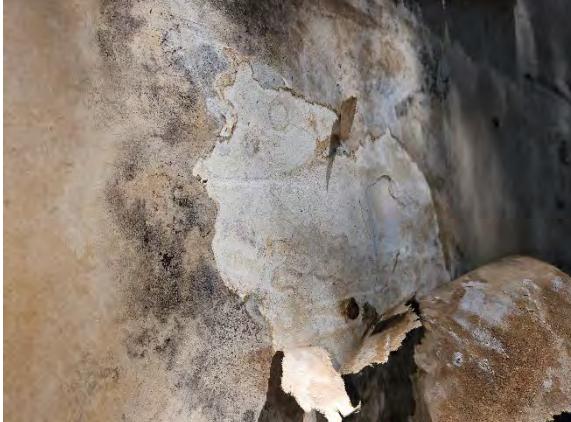
Photo 4.7: Water damaged gypsum sheathing, paper facing, fasteners, and core.	Photo 4.8: Water damaged gypsum sheathing, paper facing, fasteners, and core.

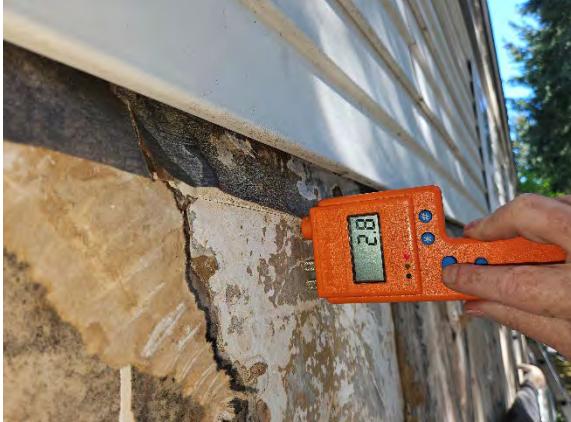
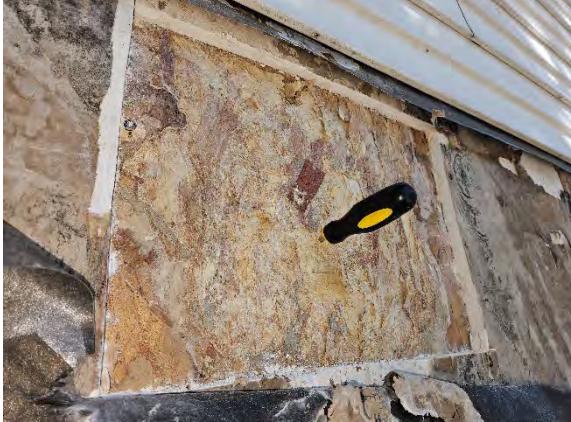
Photo 4.9: Wet reading (2.8) at gypsum sheathing.	Photo 4.10: Water damaged OSB sheathing.

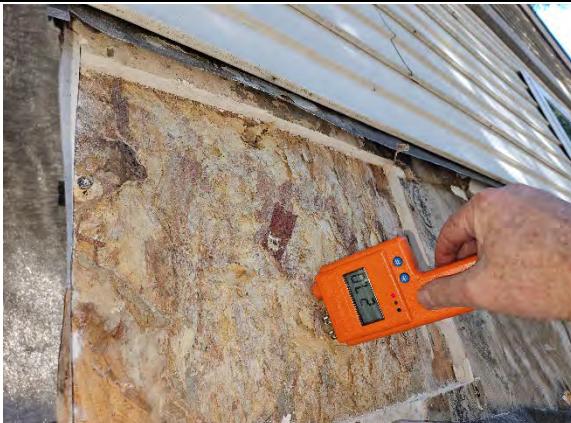
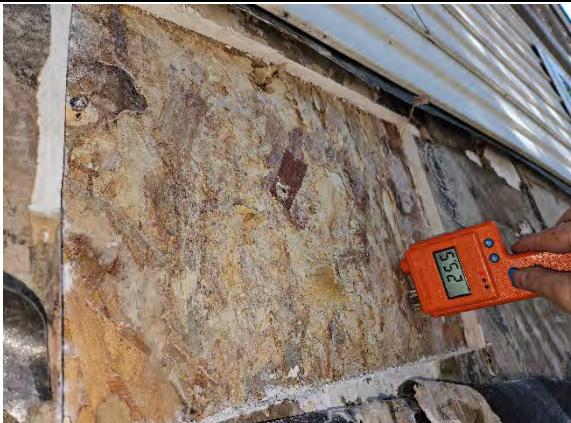
Photo 4.11: Wet reading (27.0) at OSB sheathing.	Photo 4.12: Wet reading (25.5) at OSB sheathing.

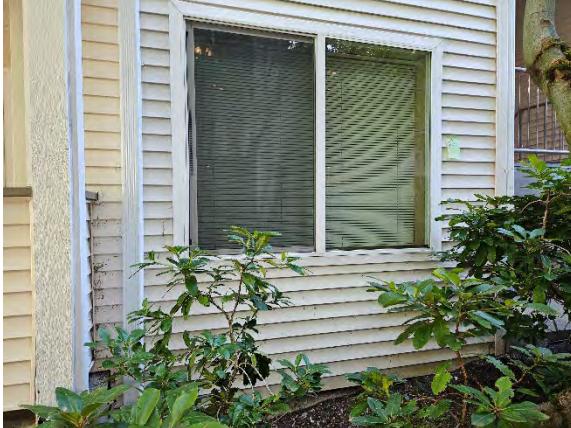
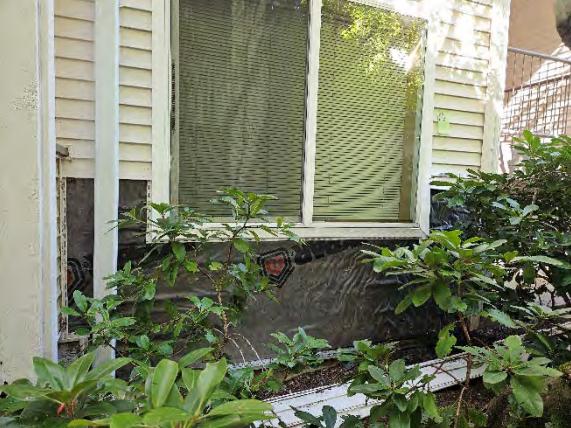
MAY 2025 OPENING 5

Photo 5.1: Opening Location	Photo 5.2: Opening following cladding removal.

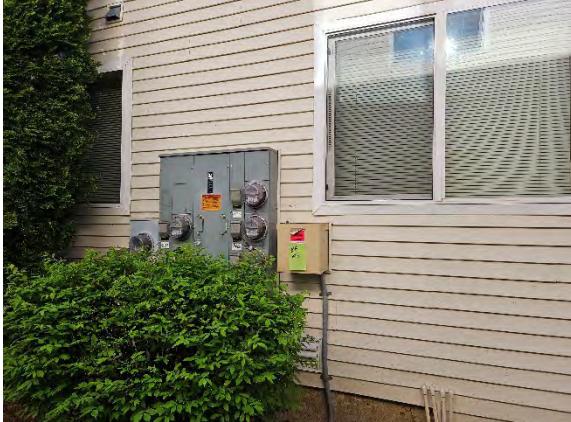
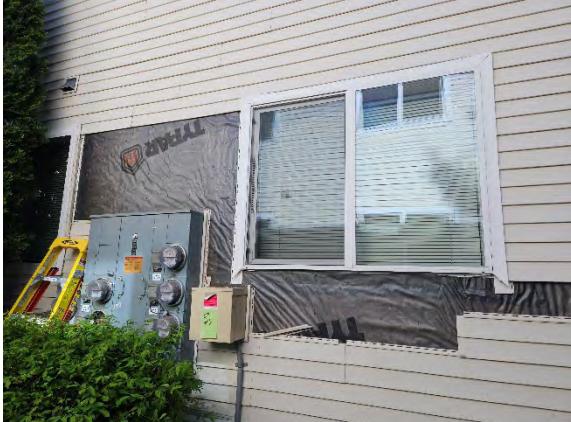
MAY 2025 OPENING 6

A photograph of the same area as Photo 6.1, but the cladding has been removed, revealing the underlying structure. The electrical access panel is visible, and a yellow ladder is leaning against the building.
Photo 6.1: Opening Location	Photo 6.2: Opening following cladding removal.

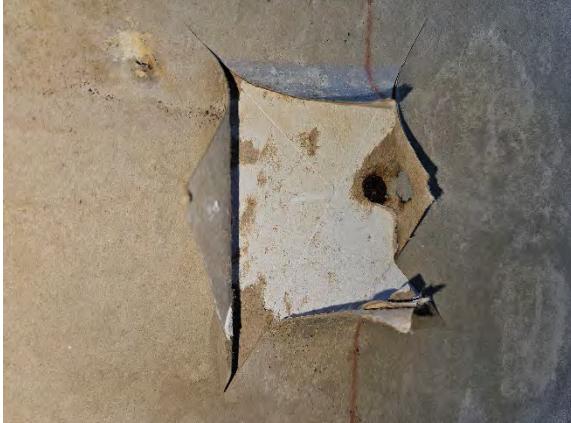
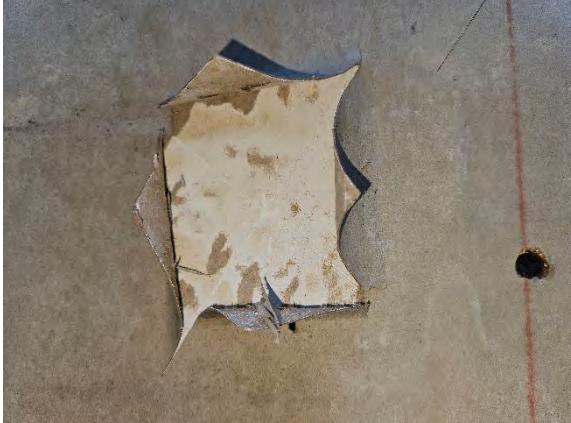
Photo 6.3: Water damaged gypsum sheathing, paper facing, and fasteners.	Photo 6.4: Water damaged gypsum sheathing, paper facing, and fasteners.

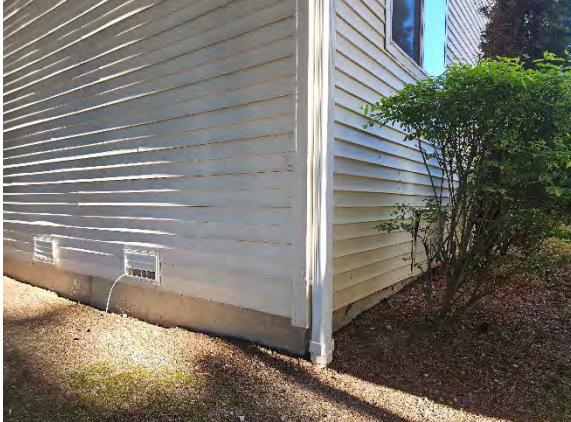
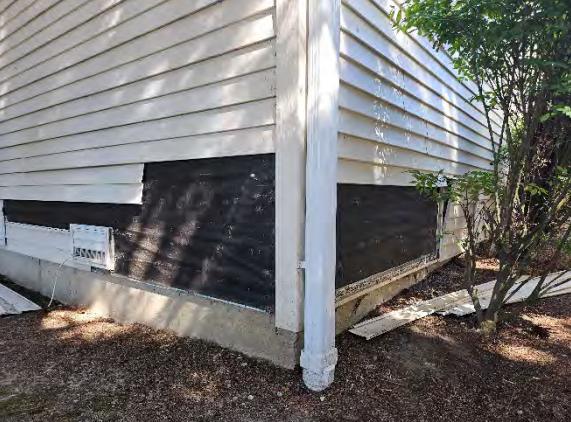
MAY 2025 OPENING 7

Photo 7.1: Opening Location	Photo 7.2: Opening following cladding removal.

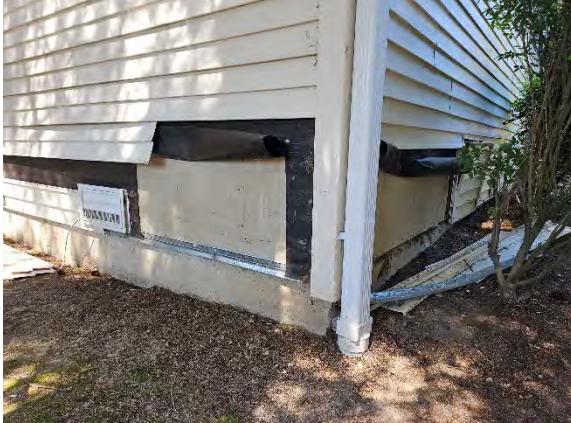
Intentionally Left Blank
Photo 7.3: Opening following WRB removal.

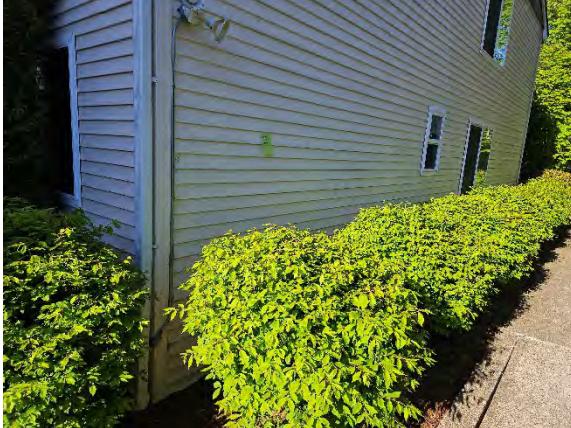
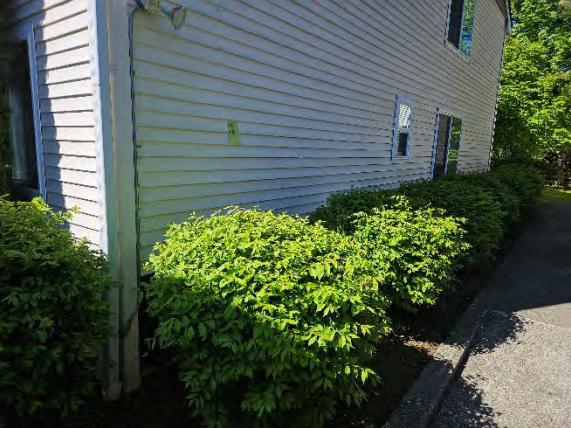
MAY 2025 OPENING 8

Photo 8.1: Opening Location	Photo 8.2: Opening following cladding removal.

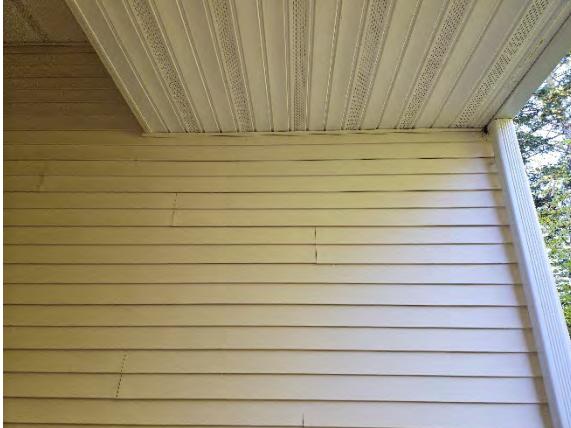
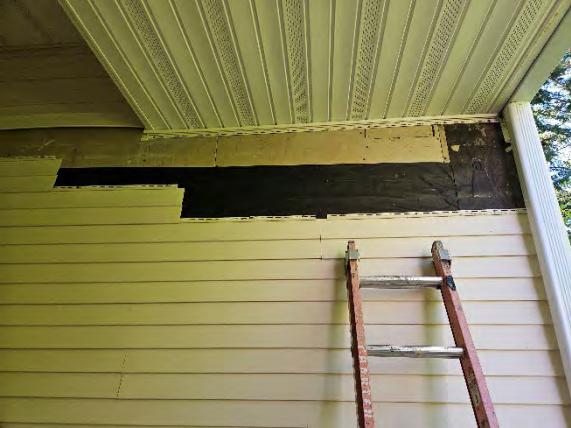
MAY 2025 OPENING 9

Photo 9.1: Opening Location	Photo 9.2: Opening following cladding removal.

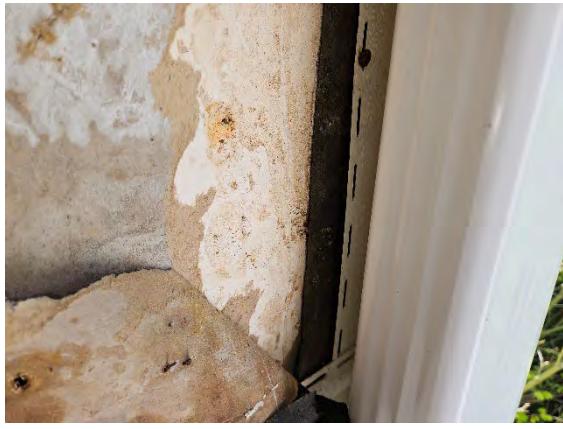
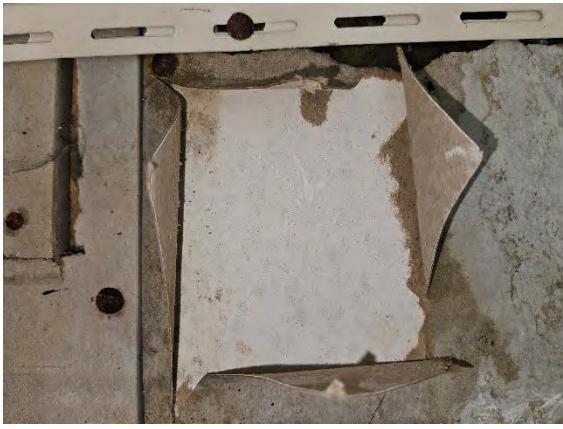
Photo 9.5: Water damaged gypsum sheathing, paper facing, and core.	Photo 9.6: Water damaged gypsum sheathing, paper facing, and fasteners.

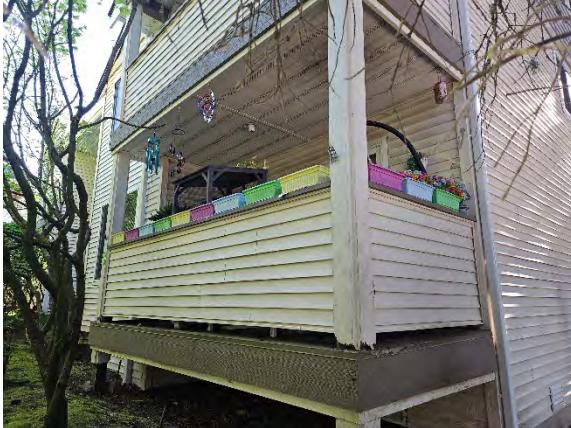
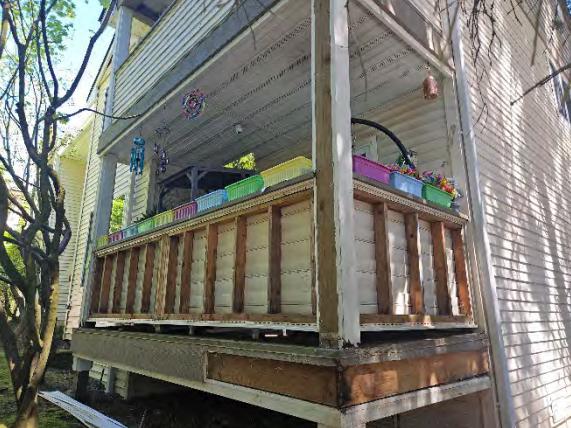
MAY 2025 OPENING 10

Photo 10.1: Opening Location	Photo 10.2: Opening following cladding removal.

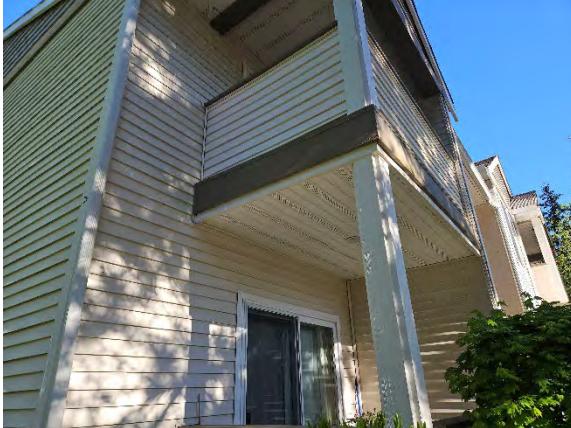
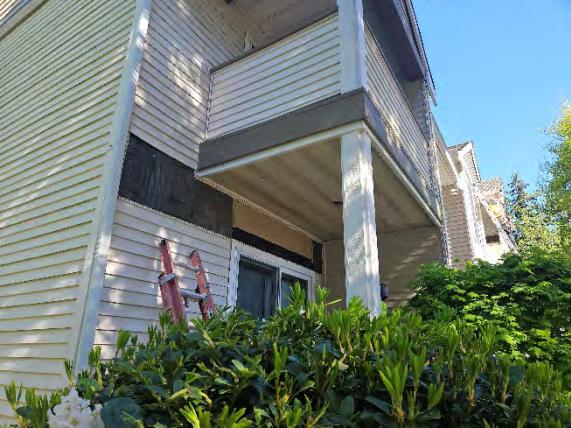
MAY 2025 OPENING 11

Photo 11.1: Opening Location	Photo 11.2: Opening following cladding/soffit removal.

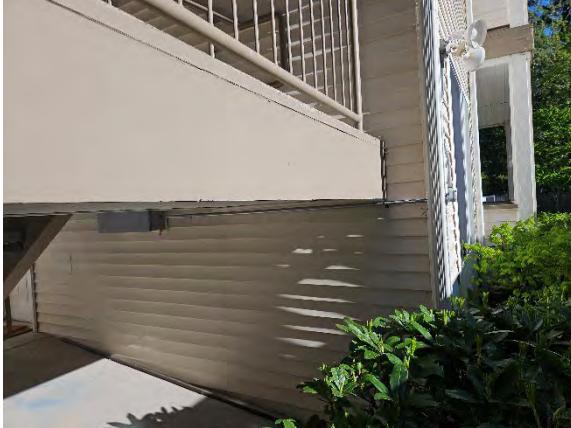
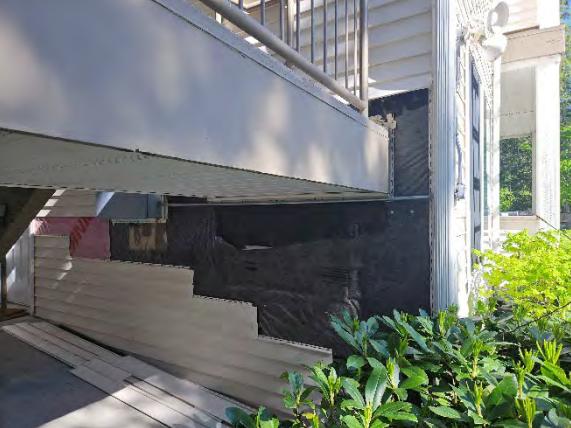
MAY 2025 OPENING 12

Photo 12.1: Opening Location	Photo 12.2: Opening following cladding removal.

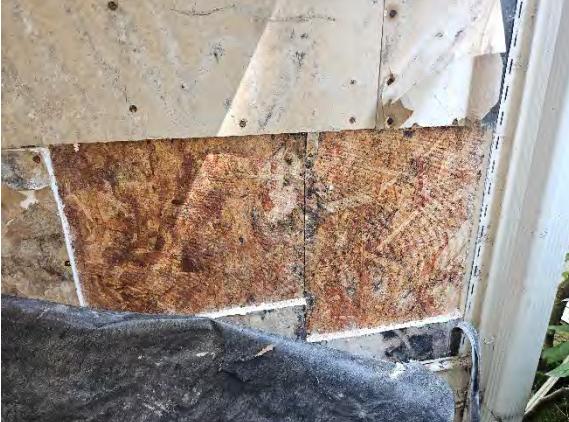
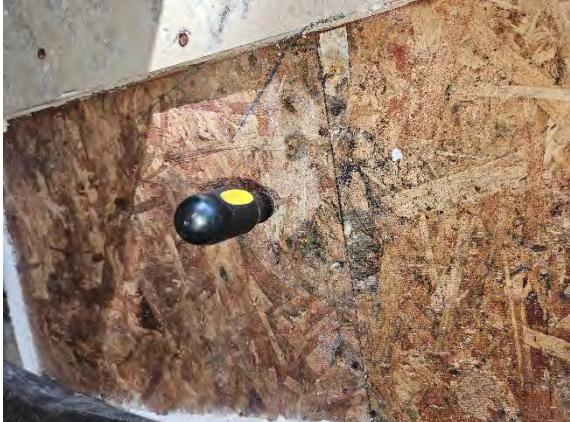
Photo 12.7: Water damaged OSB sheathing.	Photo 12.8: Water damaged OSB sheathing.

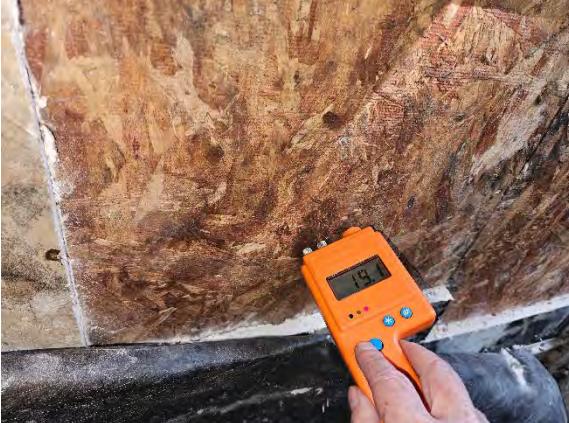
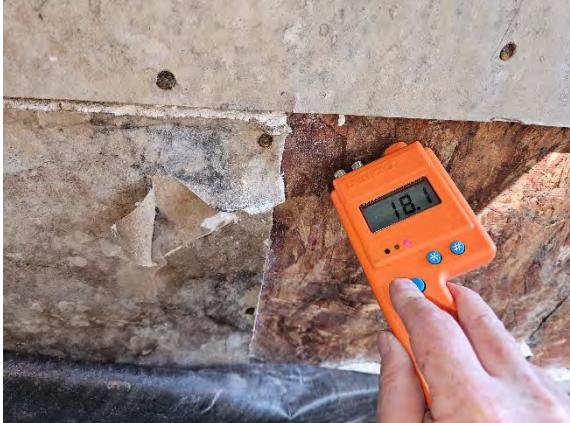
Photo 12.9: Wet reading (19.1) at OSB sheathing.	Photo 12.10: Wet reading (18.1) at OSB sheathing.

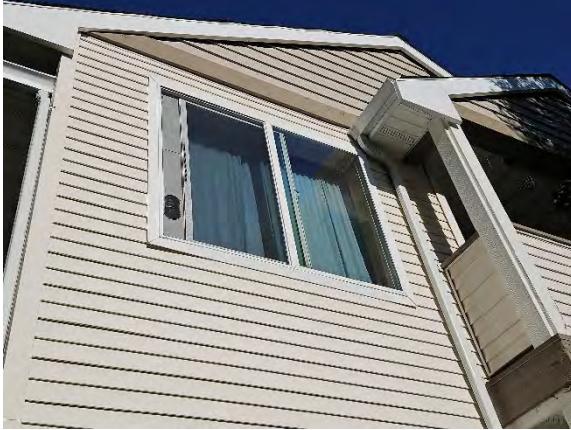
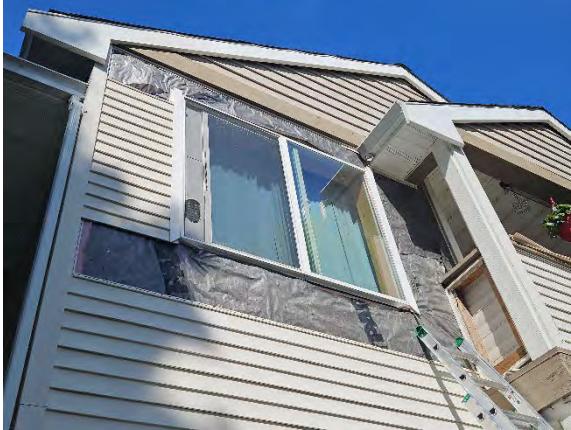
MAY 2025 OPENING 13

Photo 13.1: Opening Location	Photo 13.2: Opening following cladding removal.

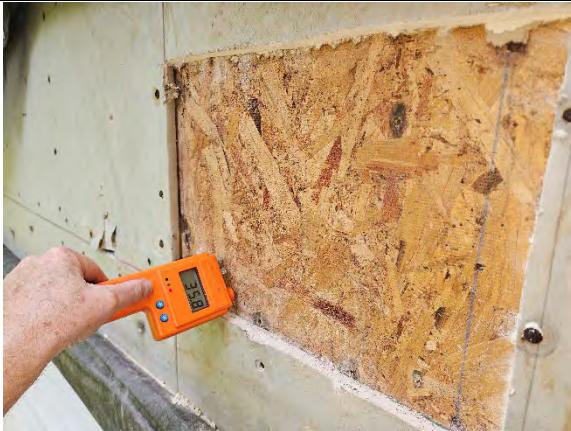
Photo 14.9: Wet reading (35.8) at OSB sheathing.	Photo 14.10: Wet reading (26.4) at OSB sheathing.

- a. Replace 100% of gypsum sheathing at exterior walls.
- b. Replace 1,000 SF of OSB sheathing at each building.

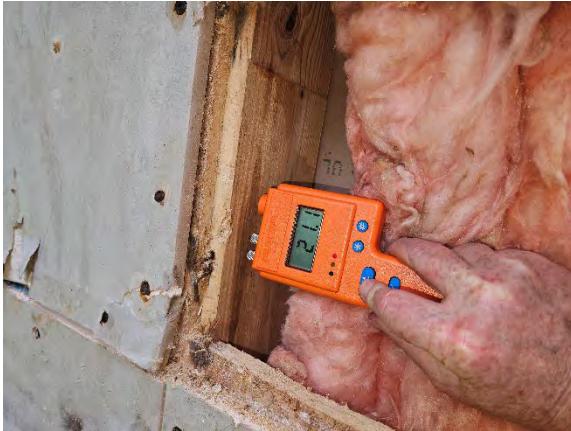
Photo 14.11: Wet reading (21.4) at framing.	Photo 14.12: Wet reading (19.4) at framing.

- a. Include an allowance to replace damaged wall framing at 10% of the exterior walls.

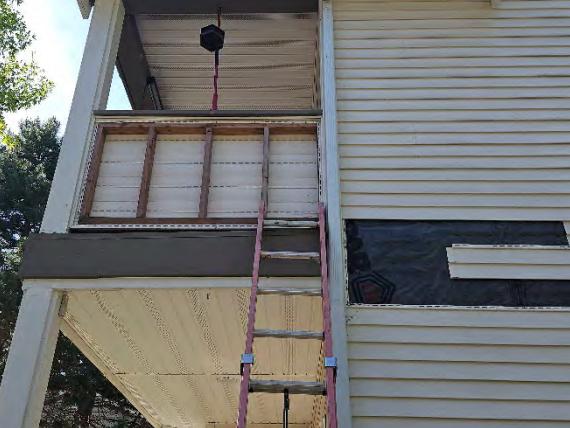
Photo 15.1: Opening Location	Photo 15.2: Opening following cladding removal.

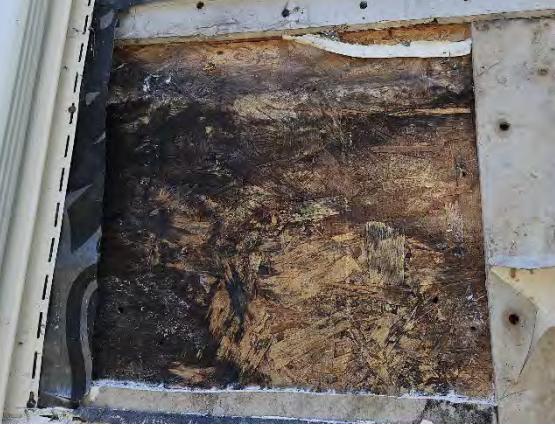
Photo 15.7: Wet reading (1.4) at gypsum sheathing.	Photo 15.8: Water damaged OSB sheathing.

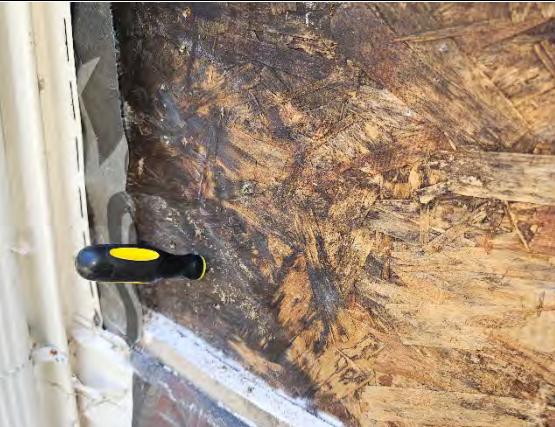
Photo 15.9: Water damaged OSB sheathing.	Photo 15.10: Water damaged OSB sheathing.

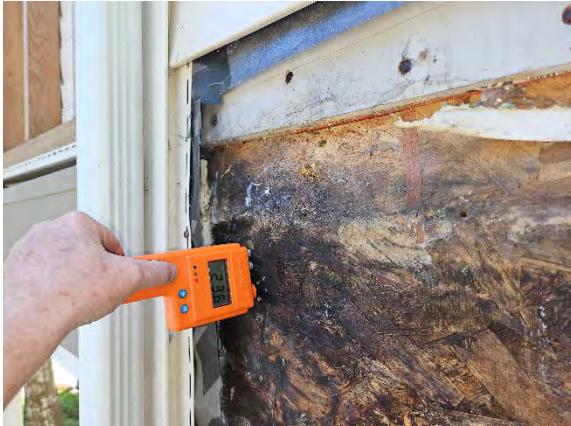
Photo 15.11: Wet reading (23.6) at OSB sheathing.	Photo 15.12: Wet reading (20.2) at OSB sheathing.

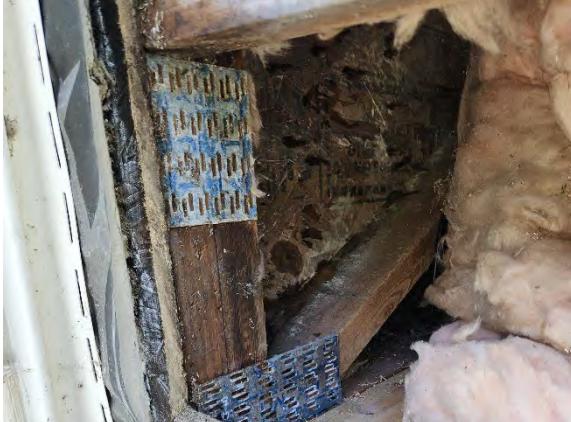
Photo 15.13: Water damaged framing.	Photo 15.14: Water damaged framing.

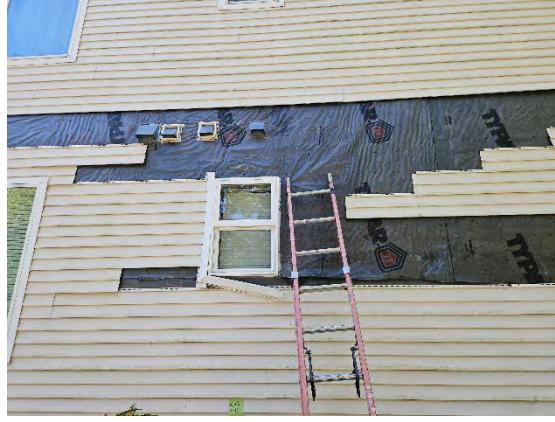
Photo 16.1: Opening Location	Photo 16.2: Opening following cladding removal.

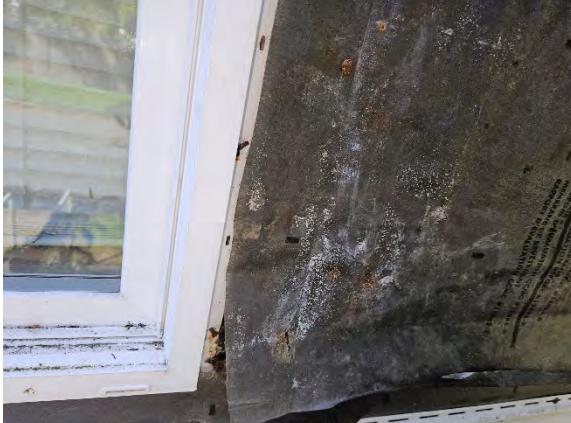
Photo 16.3: Water damaged WRB.	Photo 16.4: Water damaged WRB.

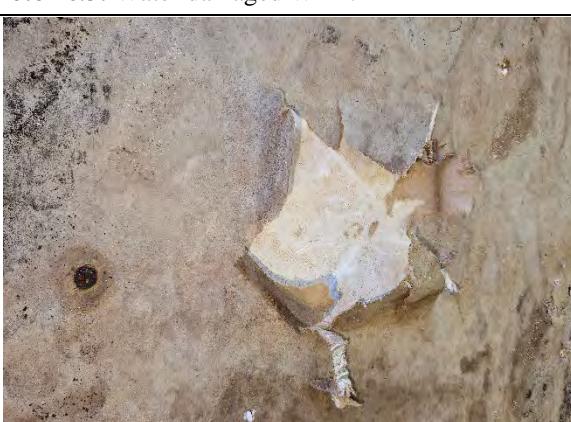
Photo 16.5: Water damaged gypsum sheathing, paper facing, and fasteners.	Photo 16.6: Water damaged gypsum sheathing, paper facing, and fasteners.

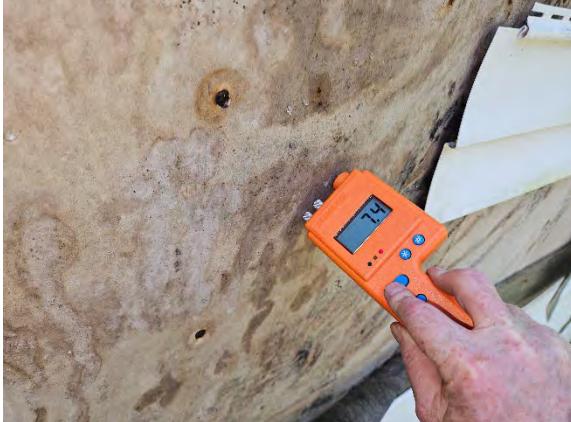
Photo 16.7: Wet reading (7.4) at gypsum sheathing.	Photo 16.8: Wet reading (1.9) at gypsum sheathing.

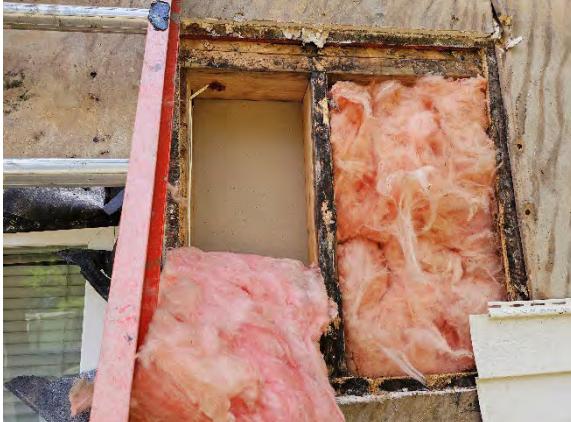
Photo 16.13: Water damaged framing.	Photo 16.14: Water damaged framing.
